BUILDING CONDITION  
ASSESSMENT REPORT

**36 Boundary Rd, Isle of  
Houghton Office Park, JHB**

**Wits Health Consortium**

Document number: IOH Condition Assessment  
Revision: 1

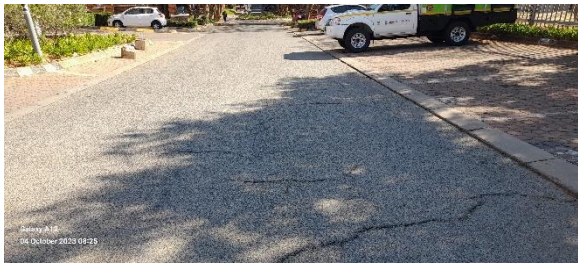
Access roads comprises of asphalt surfacing. In general, all the access roads are in good condition. There are asphalt damages and minor asphalt cracks in some areas (see **Photos 2 and 3**). There seem to be isolated layer works failure in the access road section between Old Trafford 4 and Harcourt 2 (see **Photos 4**). There is damage to kerbs (see **Photos 5**) and concrete channel (see **Photos 6**) in some areas on the access road between Old Trafford 4 and Harcourt 2.

| <p>Photo 1: Access ramp into the Old Trafford 4 Building</p> | <p>Photo 2: Asphalt cracks on Wild View access road</p> |

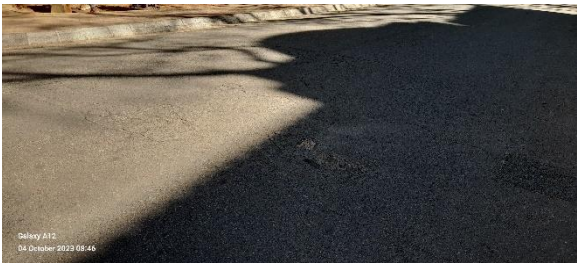
| <p>Photo 3: Cracks and asphalt damage on access road between Old Trafford and Parking building</p> | <p>Photo 4: Minor layer works failure on access road between Old Trafford and Parking building</p> |

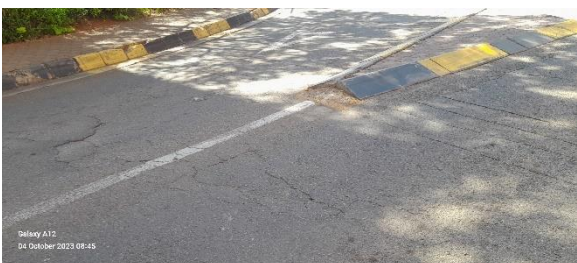
| <p>Photo 5: Kerb damage on access road between Old Trafford and Parking building</p> | <p>Photo 6: Concrete channel damage on access road between Old Trafford and Parking building</p> |

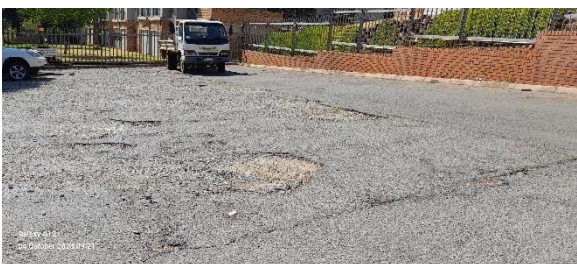
There is an open parking area for visitors on the northern side of Old Trafford 4. This parking comprises of asphalt surfacing and enclosed with kerbing. There are noticeable asphalt and layer works damages (see **Photos 7**). There is major asphalt uprooting on the northern side of Old Trafford 1 (see **Photos 8**).

| <p>Photo 7: Damage to asphalt in the visitors parking area</p> | <p>Photo 8: Major uprooting of asphalt on the northern side of Old Trafford 1</p> |

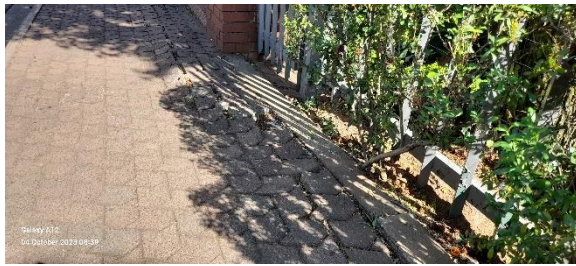
There are walkways and parking outside the buildings surfaced with block paving. In general, the paving look to be in good condition. There are minor settlement and tree uprooting of the paving in some areas. (see **Photos 9,10,11 and 12**).

**Photo 9: Uprooting of block paving on sidewalk along the main entrance**

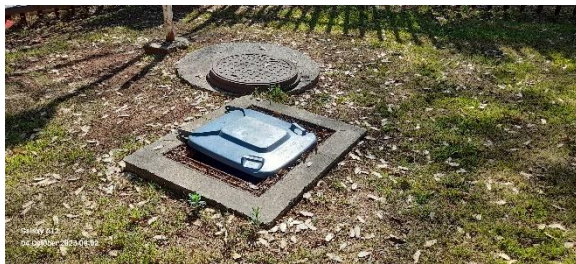
The cut-off drains located at the entrance of the basement parking look to be in good condition, but regular removal of leaves is required. There is a kerb inlet at the main entrance (on exit side) that is fully blocked with (see **Photo 13 and 14**). There is a stormwater manhole cover missing on the eastern side of Old Trafford 1 (see **Photo 15**).

**Photo 15: Missing stormwater manhole cover**

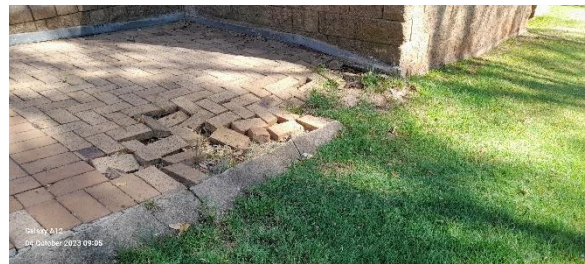
All the buildings have apron slabs around the buildings. These apron slabs are constructed of bricks and generally look to be in good condition. There is an area on the eastern side of Old Trafford 1 where the apron slab has collapsed (see **Photo 16**).

**Photo 16: Collapsed apron slab**

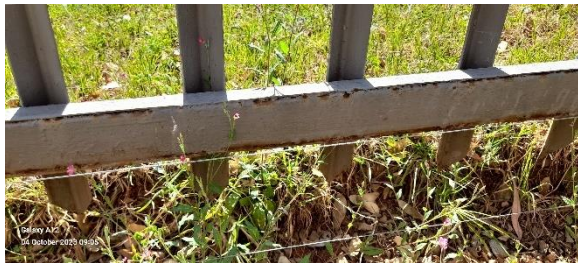
**Photo 21: Palisade fence rusting**

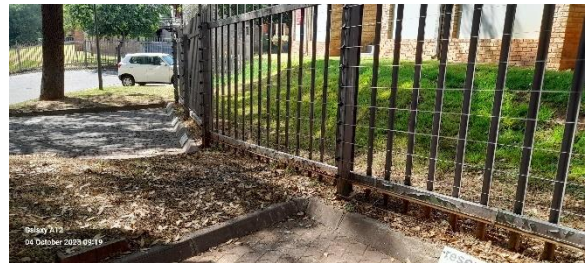
**Photo 22: Palisade fence paint peeling off**

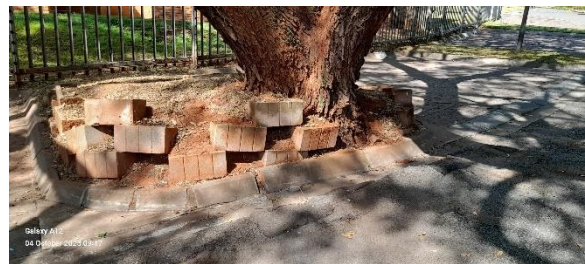
**Photo 24: Loffelstein retaining wall damaged by tree roots**

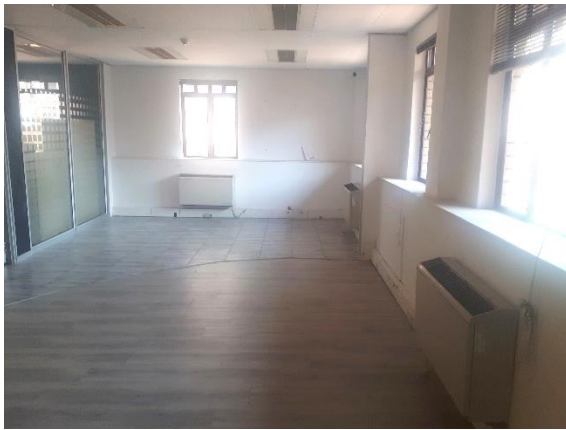
**Photo 1: Photo showing typical console units installed in office area, note no fresh air supply to offices**

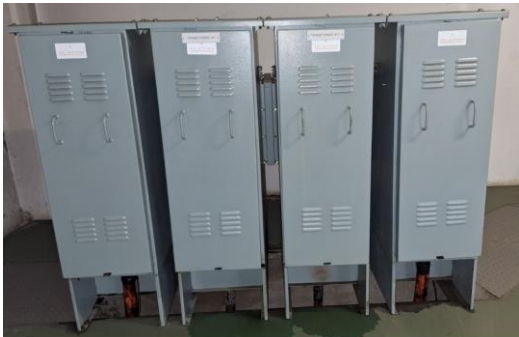
4-way 11kV ring-main unit with slight oil leak at bottom

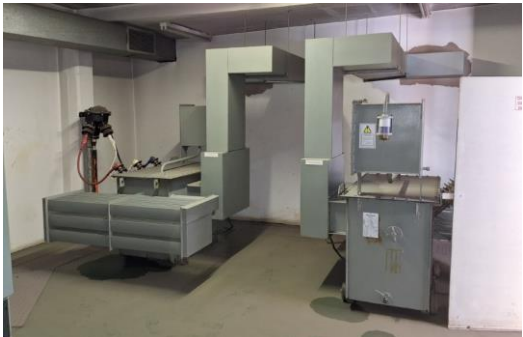
2 x 500kVA transformers, each with slight oil leaks

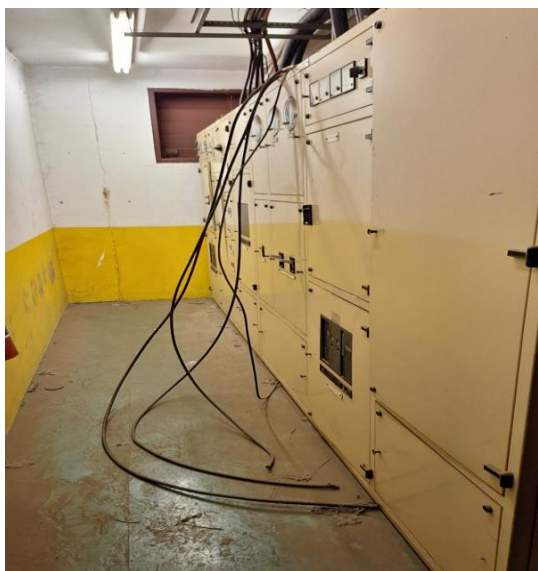
**Harrow Court Building  
Main LV Panel**

The switch gear inside the panel is old and some replacement may be required. Some sub-metering is in place. These are old electro-mechanical meters without any interfacing capabilities. These types of meters have become obsolete.

The panel is in a fair condition and in need of maintenance. Non-connected earth wires are concerning and should be rectified urgently.

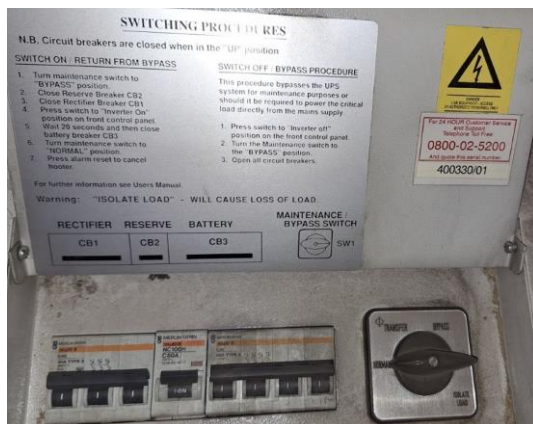
**On-board UPS circuit breaker panel with clear  
signs of lack of maintenance**

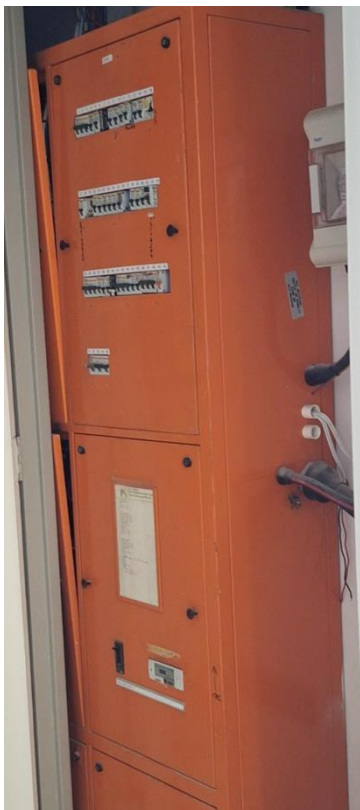
**Loose faceplates on DB. Unused conduit entry, to be sealed.**

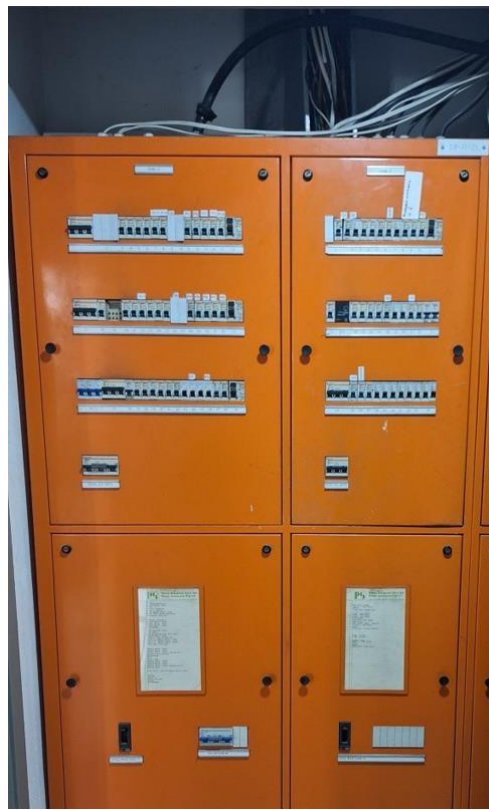
**No wireway and unsupported wiring**

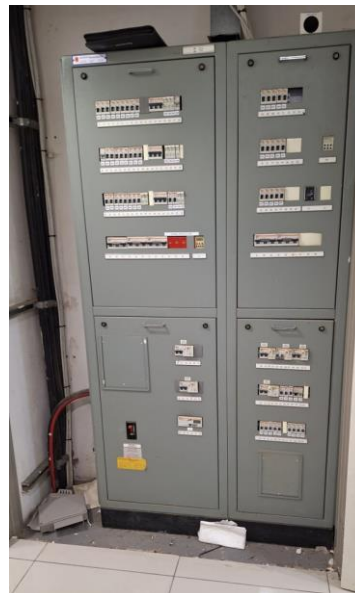
**DB in reasonably good condition. DB cupboard untidy inside**

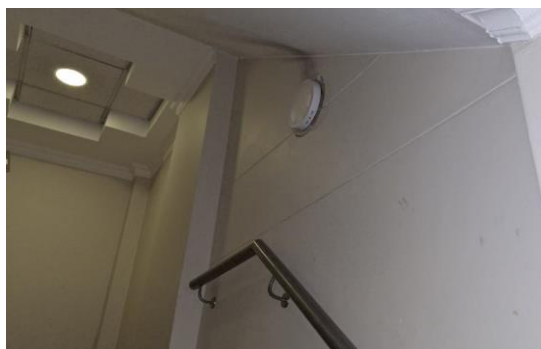
**Failed LED bulkhead light on staircase**

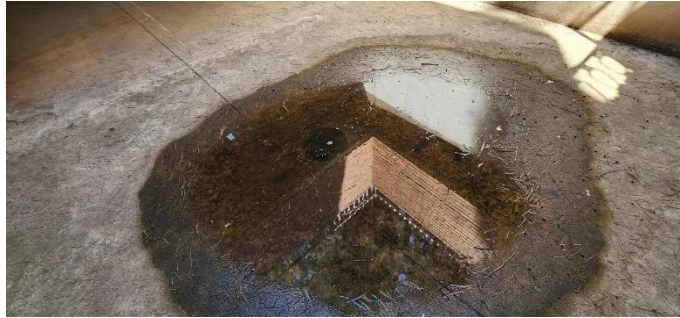
**Old Trafford rainwater drain needs to be cleaned out.**

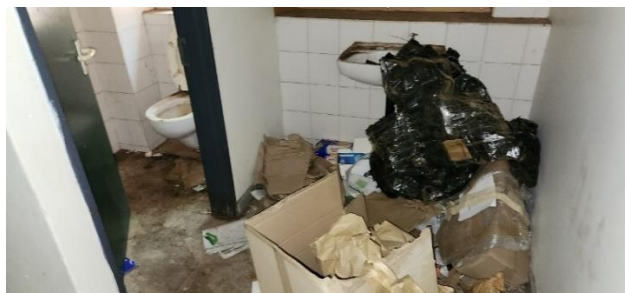
**Repair work required Wild View 2**

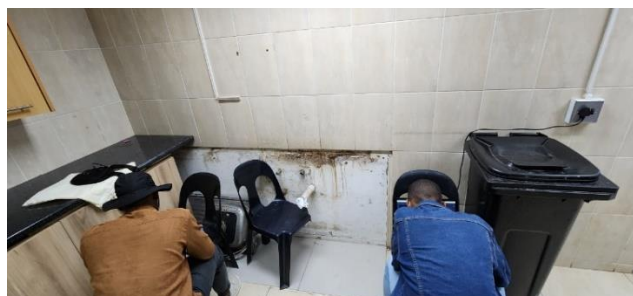
**Missing Fittings – Gauteng Cit College – ground floor**

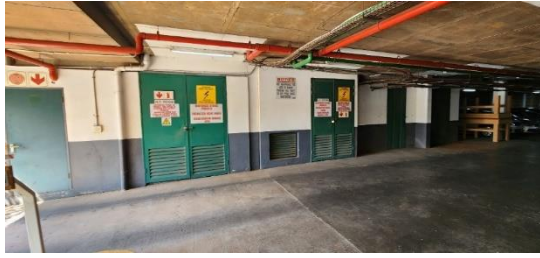
**Main Electrical DB's located in the various basements to have 2 x 5kg CO<sup>2</sup> extinguishers, located on the outside of the DB room and not inside the room.**

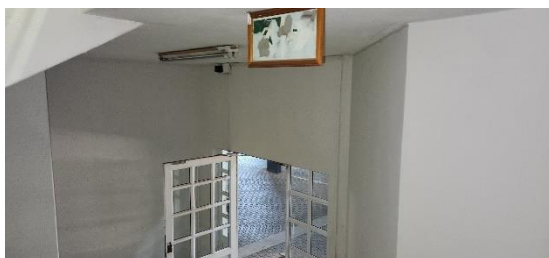
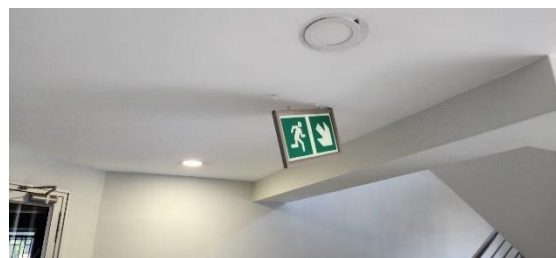
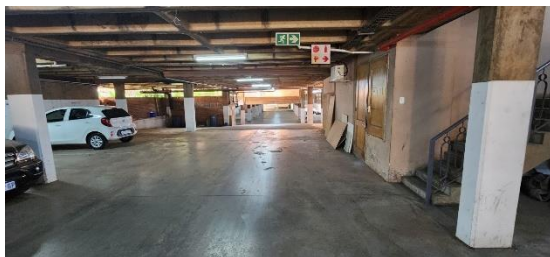
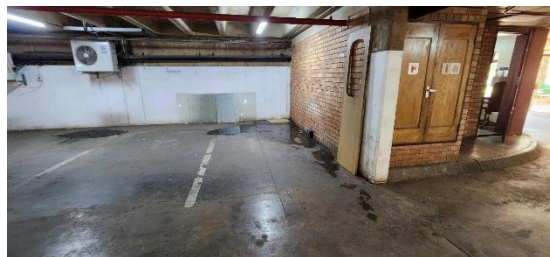
**Replacement of missing and damaged signage needs to be corrected**

Fire signage needs to be installed as per SANS 10400 Part T section 4.29 and SANS 1186-5. A thorough assessment needs to be conducted to ascertain which signage needs to be corrected and replaced.

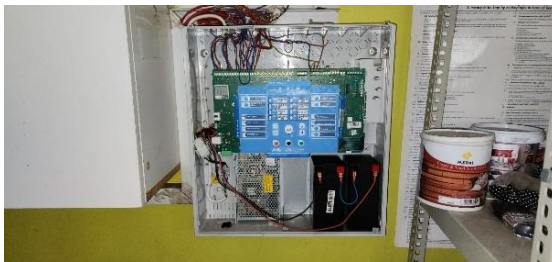
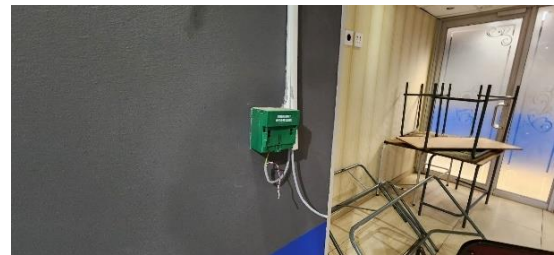
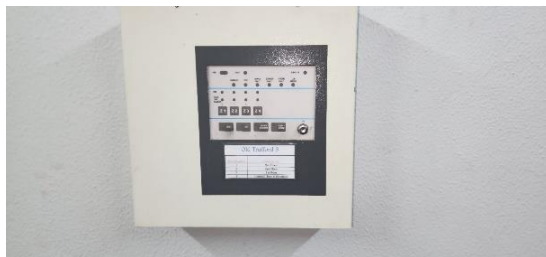
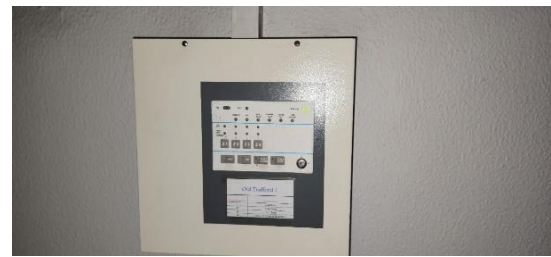
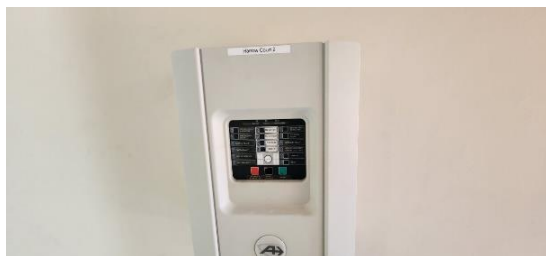
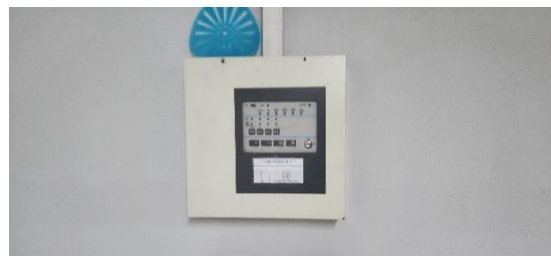
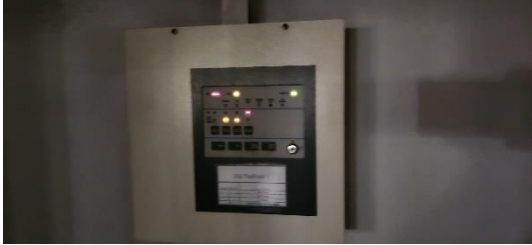
- ▶ The smoke detection is need of major repairs. Numerous maunual call points, detectors, etc are damaged. Badly damaged cabling was also observed.
- ▶ The system needs to comply with SANS 10139.
- ▶ We informed by the caretaker that a repair quote has been issued and will be actioned shortly, to repair the system to working order.

**Damaged smoke detection system**

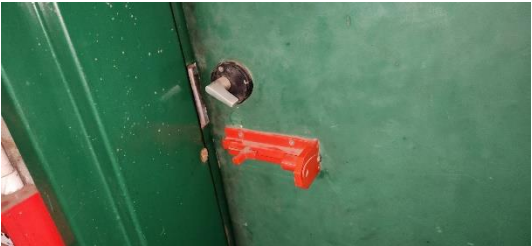
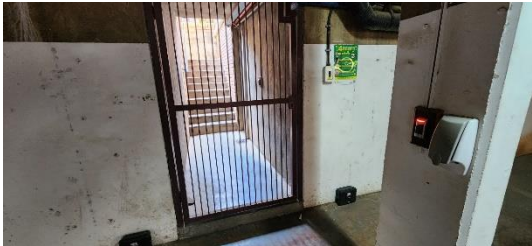
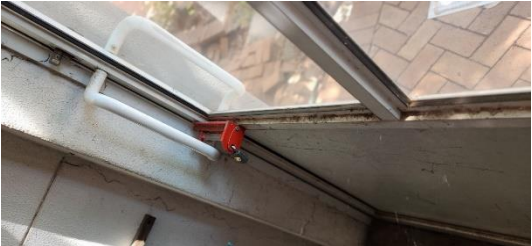
| <p><b>All escape doors require all Redlam bolt's to be fixed or repaired.</b></p> | <p><b>All escape doors require all Redlam bolt's to be fixed or repaired.</b></p> |
