Abstract

Thin spray-on liners (TSLs) are a type of surface rock support used in underground excavations, for maintaining stability at the excavation boundary. Different products are emerging in the market, while little is known about the mechanisms by which the liners support the excavation. There are no generally accepted tests which determine the performance of TSLs for rock support. In the research described in this dissertation, an attempt has been made to investigate the mechanisms of behavior of TSLs for rock support through laboratory tests. Brazilian indirect tensile strength tests, material compression tests, 3-point bending tests and physical model tests were carried out to investigate the performance and the characteristics of the liners for rock support. The Brazilian and the 3-point bending tests are new tests as far as TSL evaluation is concerned. The reviews of literature indicate that no similar testing appears to have been done previously.

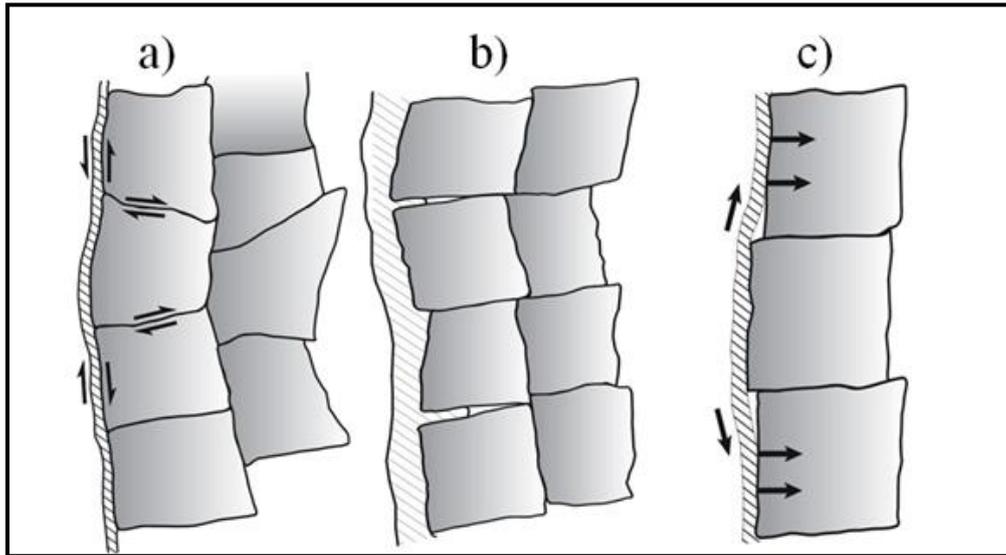
Figure 2. 2 a) Shear and rotational resistance, b) crack infilling and c) tensional resistance (After Stacey 2001)

According to Daehnke *et al*, (2000) the fragments on the boundaries of excavations are created by natural discontinuities such as bedding planes, joints and faults, as well as mining induced fractures due to blasting and excessive static stress. These fragments, if not supported, may rotate and move obliquely, resulting in block failure. Thus, by retaining the fragments together, surface support prevents the rock mass from dilating, loosening and unravelling, reducing the likelihood of formation of further cracks. Stacey (2001) identified the mechanism of promotion of interlock of small key blocks in the preservation of stability. Promotion of block inter lock involves other sub mechanisms such as penetration of the liner into the joints and restricting rotational shear, due to the tensile and bond strengths of the material (Figure 2.2). Archibald *et al* (2000) estimated that a 2mm liner is capable of supporting a wedge that imposes gravity loading of as much as 7 tonnes per square metre, as long as liner adhesion and crack filling exist. Hoek and Brown (1980) pointed out that this mechanism is particularly important in assisting the rockmass to support itself.

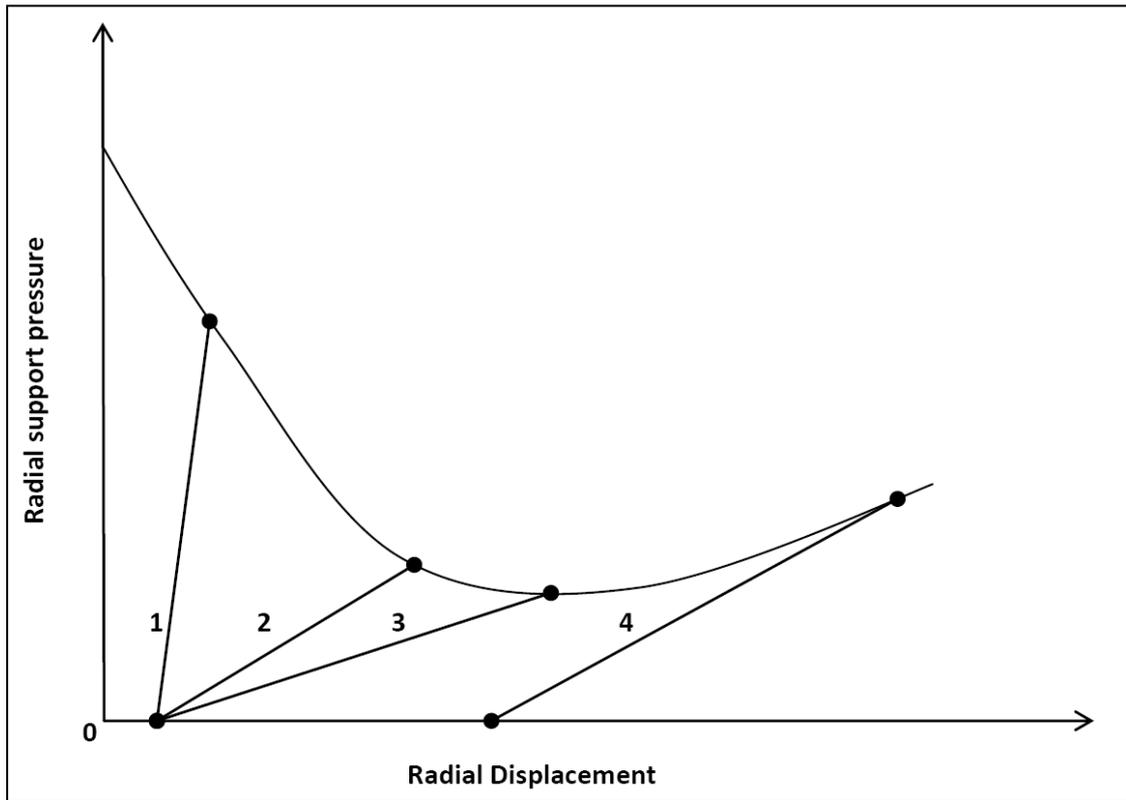
Figure 2. 3 Support Reaction Curve after (Brady and Brown, 1985)

Brady and Brown (1985), Cristescu and Duda (1989), Vandewalle (1998) and Kuijpers *et al* (2004) report that the stiffness and time of installation of the support element has an influence on displacement control. The effectiveness of surface support for an underground excavation, can be assessed in terms of support pressure. According to Cristescu and Duda (1989) the main aspects are the stress evolution in the support, the pressure and the displacement at the interface of the surface support, taking into consideration the thickness of the unstable ground. Furthermore, the condition under which stabilization was reached was dependent on the characteristics of the surface support and the post failure residual strength of the rockmass. Brady and Brown (1985) presented a conceptual surface support reaction curve shown in Figure 2.3. The following discussions concern the development of displacement at a point on the periphery of the excavation as the heading advances, and the behaviour of different surface support systems represented by line 1, line 2, line 3 and line 4 as seen in Figure 2.3. In the discussion the term surface support refers to a TSL and will be used in the section to describe the effectiveness of support that was encountered in the support reaction curve.

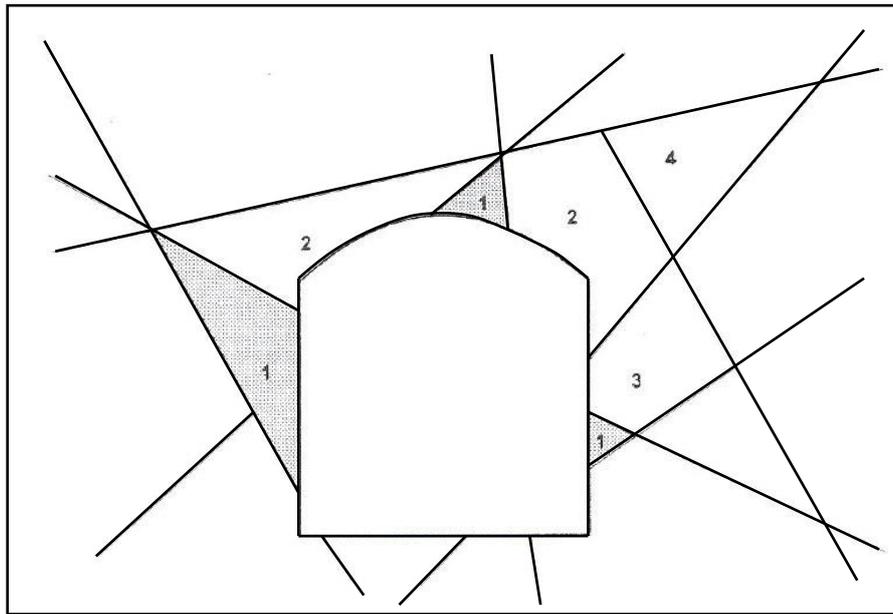
Figure 2. 4 Key block theory; shaded blocks are unstable (After Barrett and McCreath 1995)

This type of liner loading occurs in excavations where the major rock failure mechanism is gravitational loading. As previously mentioned, the movement of a key block subjects the liner to punch loading across the joints giving rise to tensile or shear loading depending on the relative block movement (Figure 2.4).

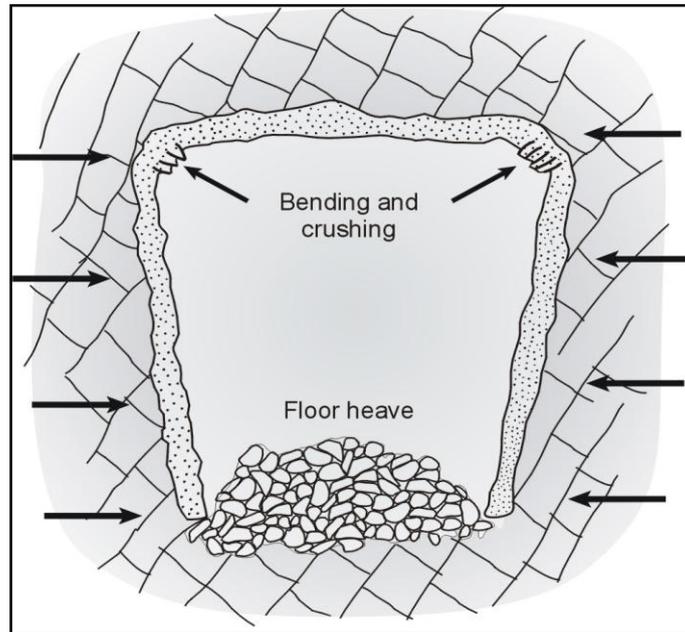
Figure 2. 5 Squeezing ground (After Stacey 2001)

The bending loading mechanism is found in highly stressed ground such as deep level gold mines. Stacey (2001), Stacey and Yu (2004) reported that, if support is installed on the sidewall and the roof leaving the floor to deform freely Figure 2.5 then, squeezing ground present localized loading of surface support resulting in bending or rotational moments on the sidewall and the roof, while the haunch areas are subjected to compression loading.

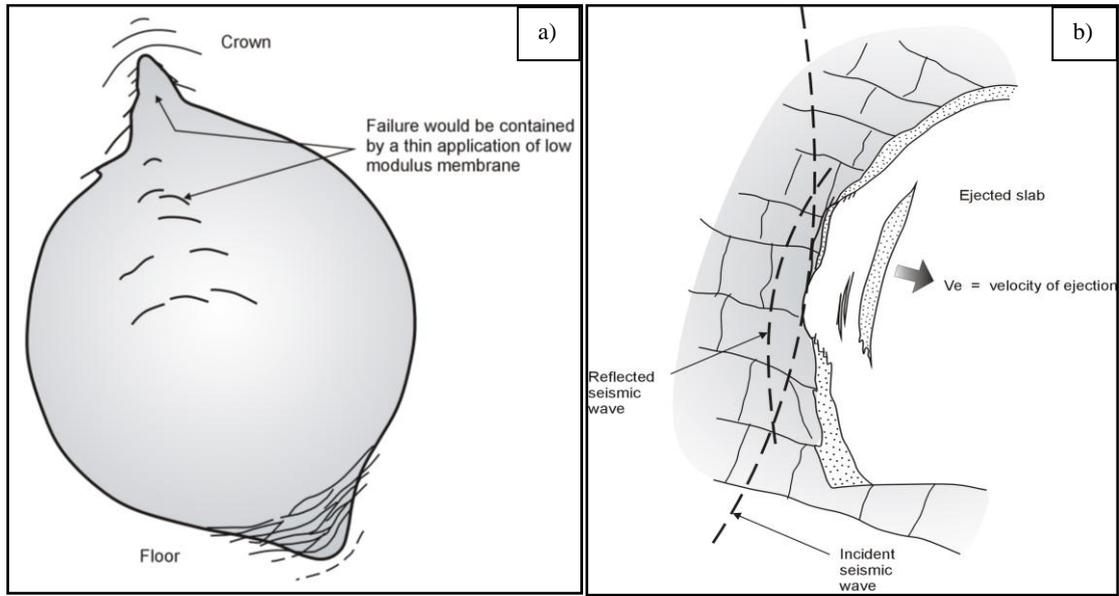
Figure 2. 6 a) Stress induced Spalling b) Seismic spalling of brittle membrane (After Stacey 2001)

If induced stresses increase in the rockmass such that, they exceed the rock strength, violent failure of the rock surrounding excavations occurs. The dynamic load is transferred to the surface support and regardless of the mechanical properties of the surface support, the load imposed on the liner is greater than the mechanical properties of the liner (Figure 2.6 b). However, a flexible liner reduces the impact even though ultimate failure occurs.

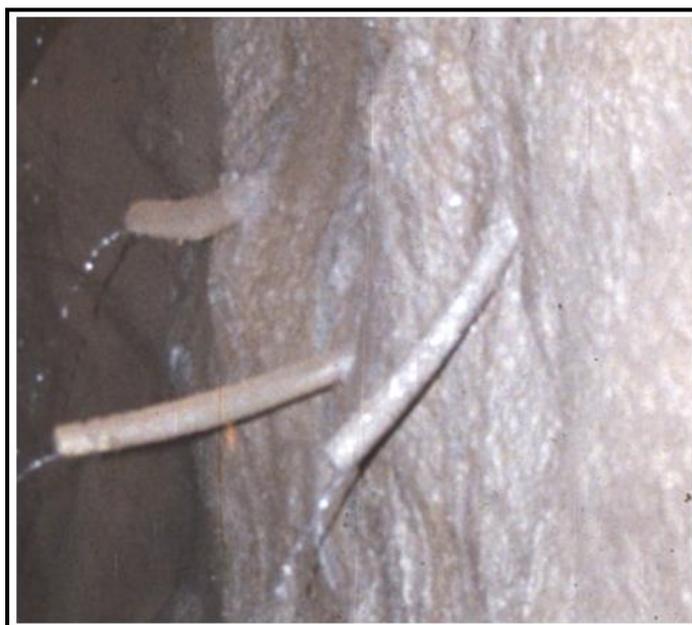
Figure 2. 7 Plastic fitted drain holes After (Hoek, 2011)

Water pressure loading reduces the effective adhesive strength of the liner. Stacey (2001) pointed out that the accumulation of ground water in the rockmass induces water pressure loading to the liner, which may be sufficient to cause failure if undrained. Drain holes fitted with plastic pipes (Figure 2.7) or a porous fibre mat attached to the surface of the rock are used for this purpose (Hoek, 2011).

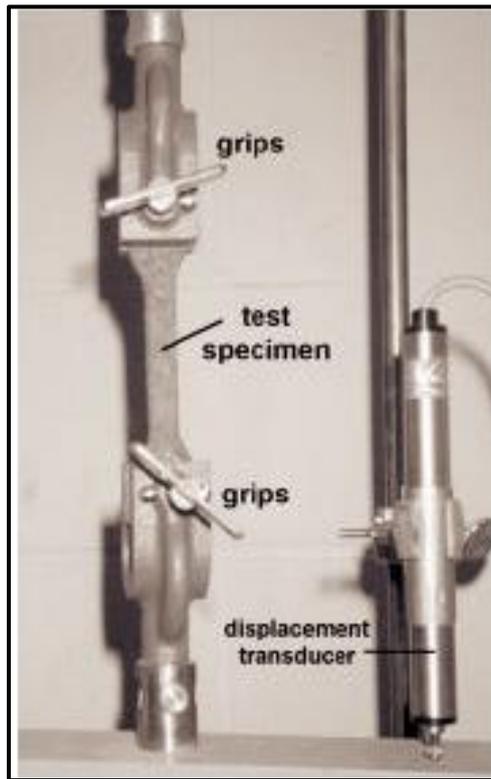
Figure 3. 1 Tensile test after, Tannant *et al* (1999), Spearing and Gelson (2002)

The test utilizes standard dog-bone shaped specimens prepared by machining, stamping, or moulding the liner material using prepared plastic moulds. The test provides an easy comparison between liner products. However, Nielsen (1962) argues that the results obtained at a single temperature and single loading rate are inadequate, as the variation in properties is a function of time and temperature. He found that at lower temperatures the material the strength and the modulus are higher. This is relevant to the properties of the TSL in mine situations where ambient conditions are subject to considerable variations.

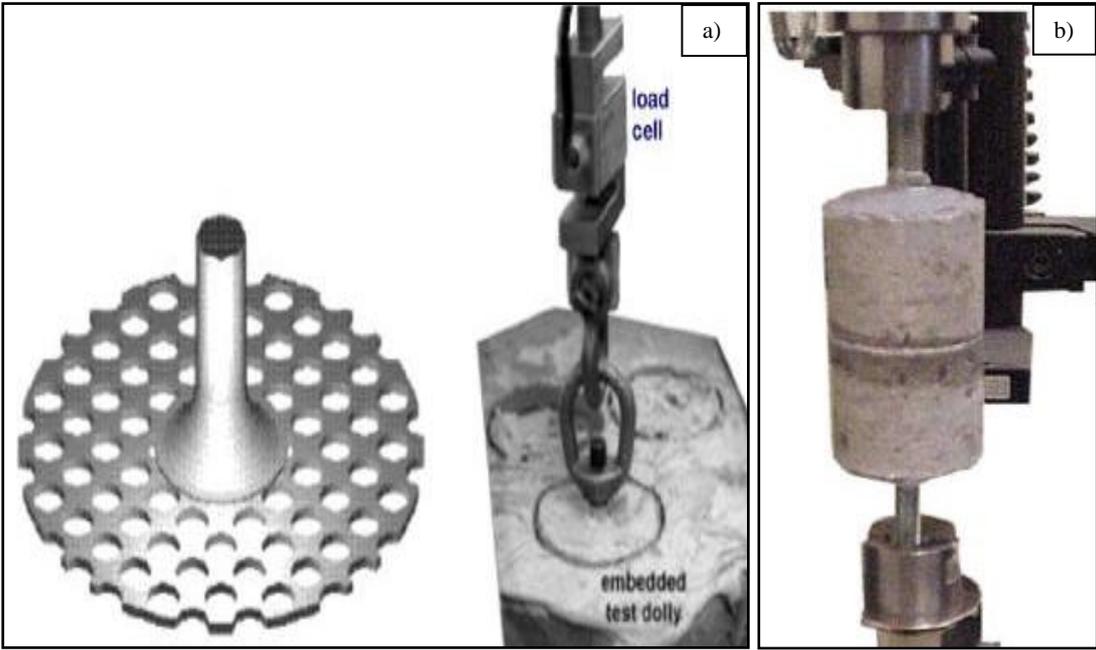
Figure 3. 2 a) Adhesion test (Tannant *et al*, 1999) b) Core to core adhesion test (Spearing, 2001)

Spearing (2001) describes the core adhesion tests consisting of two pieces of core bonded together by TSL and then pulled apart until de-bonding at the liner-rock interface occurs (Figure 3.2 b). The challenges associated with this test are the core alignment during preparation so as to prevent eccentric loading, and that curing starts at the edges of the core, affecting the curing rate at the centre of the core, and hence affecting the credibility of the results. Kuijpers (2004) carried out embedded dolly test using wet cubes of concrete that were submerged in water for 24 hours. The results showed that under humidity or with wet surfaces the adhesive bond between the liner and the rock degrades. The results of core adhesion tests carried out by Espley *et al* (2001) showed that bond strength increases with clean, dry hard surfaces and curing time. Potvin *et al* (2004) concluded that no standard methods currently exist for determining adhesion bond strength, though researchers have considered many adhesion test protocols.

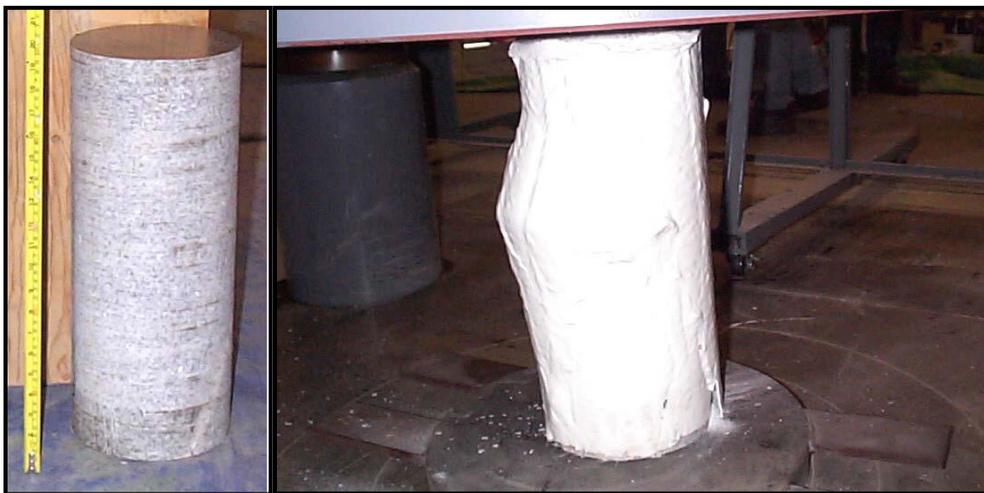
Figure 3. 3 Core sample and controlled lined rock core failure (Tarr *et al* 2006)

The test method demonstrates the ability of surface support to provide structural reinforcement to pillars by reducing damage and by absorbing stored strain energy. Best results are achieved when de-bonding of the liner occurs. A number of researchers (Lau *et al*, 2008, Tarr *et al*, 2006, Kuijpers, 2004, Archibald and DeGagne, 2000) carried out tests on coated cylinders of core to verify support offered by TSLs. They found that flexible TSL has the ability to absorb stored strain energy following non-violent post peak failure, that is, basket mechanism. However, Kuijpers (2004) notes that while results of coated core samples are difficult to interpret in terms of TSL design, they demonstrate how the limited support could have a relatively large effect in terms of stability and load carrying capacity of the supported rock (Figure 3.3). The results also show the change from violent and brittle failure to smooth ductile failure, and the extent is directly related to the thickness of the liner. The challenge associated with this test is to achieve a uniform thickness of the liner on a curved surface.

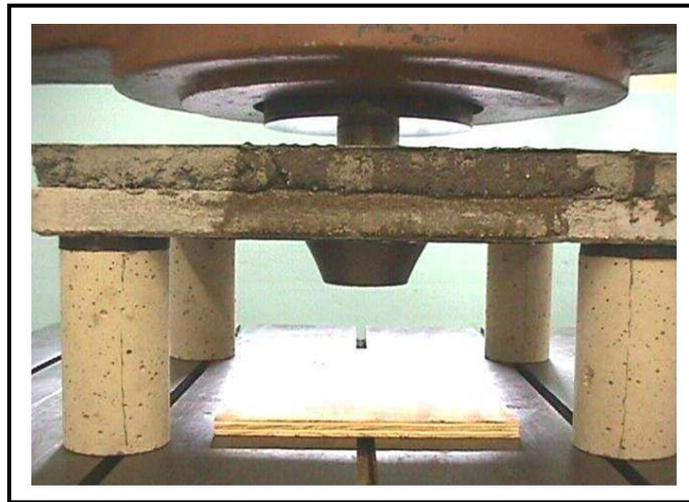
Figure 3. 4 Punch through test (Spearing *et al* 2001)

Spearing *et al* (2001) performed the punch through test to provide performance data for evaluating TSL materials and established that the combined effects of tensile, tear, shear and bond strength occurred in this test. Kuijpers *et al* (2004) added that tear strength cannot be ignored in punch through tests.

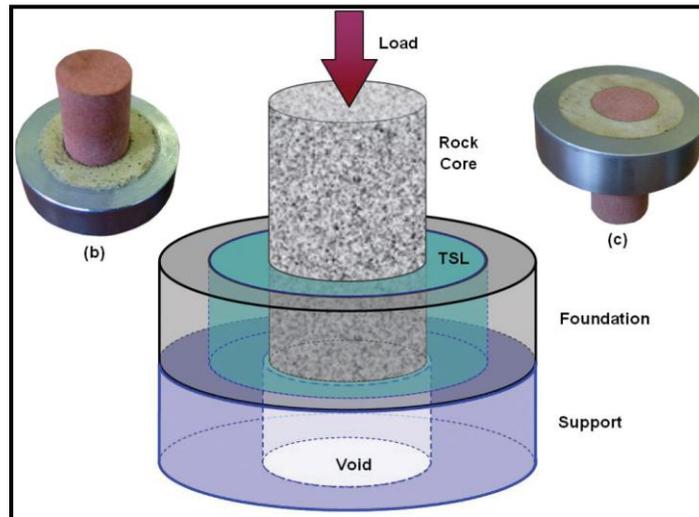
Figure 3. 5 Shear bond strength testing (Yilmaz 2007)

The shear bond strength test was developed by Yilmaz (2007) (Figure 3.5), aimed at quantifying bond resistance against shear in particular cases where the TSL penetrates into the cracks of fractured rocks. Liner material penetrates into joints of fractured rocks promoting block interlock thereby improving the integrity of the rockmass. The results showed an increase in shear bond strength with increasing curing time. In addition, the comparison of shear-bond strength for various TSLs in the market was possible.

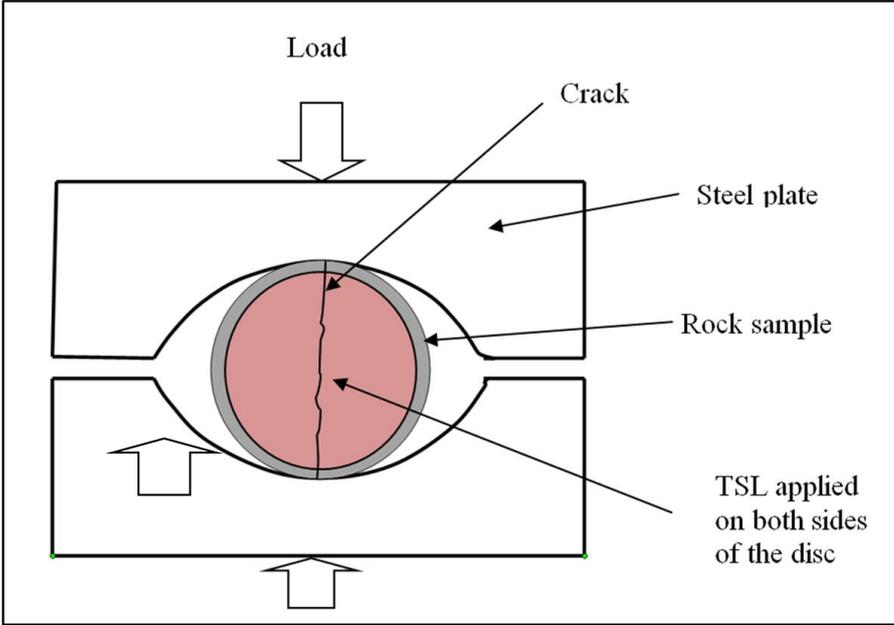
Figure 3. 6 Test setup for Brazilian test

Brazilian strength testing was carried out using the MTS testing machine. A loading rate of 0.001mm/s was used with specimen dimensions of 36mm in diameter and 18mm in thickness as shown in (Figure 3.6). The liner was applied to both sides of the circular specimen on the flat faces and perspex with thicknesses of 1mm, 3mm and 5mm was used to guide the thickness of the applied liner material. The diameter of the applied liner was 34mm, slightly smaller than the diameter of the rock specimen. The reasons for smaller liner diameter as compared to the rock specimen are ease of application of the liner using the perspex as the guide to control the thickness and hold the liner in place during drying. The other reason is to isolate the liner from being loaded directly by the platens so that an unbiased assessment of the liner performance can be made. It is also possible that the liner could detach from the rock sample if loaded directly. The liner was then allowed to cure for 1day, 7days, 14days and 28days before testing.

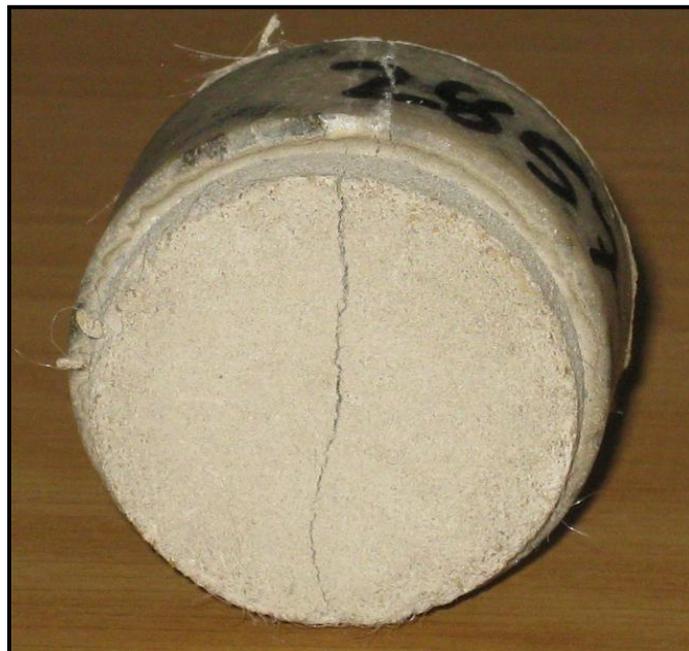
Figure 3. 7 Failed Brazilian specimen

The above equation assumes isotropic material properties. The formula gives the indirect tensile strength perpendicular to the loaded diameter at the centre of the disc at the time of failure when the applied load is P . Failure initiates at the centre of the core and propagates outwards along the loading line in the loading direction, splitting the specimen into two halves (Figure 3. 7). The strength characteristic of the liner is thought to be responsible for inhibiting the tensile failure of the rock specimen.

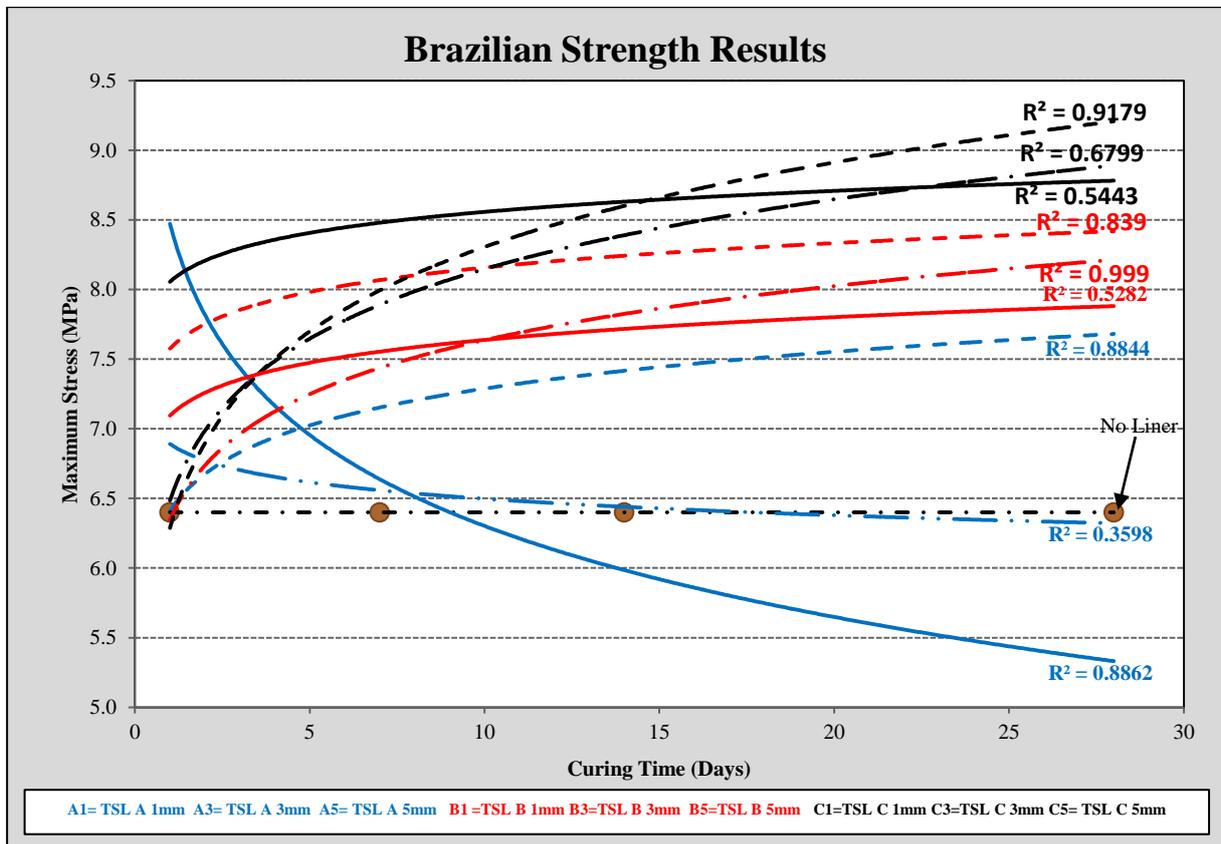
Figure 3. 8 Brazilian Strength Test Results for TSL A, B and C

TSL	Tensile Strength Equation	R ²
TSL A 1mm	$y = 0.311\ln(x) + 6.411$	0.88
TSL A 3mm	$y = 0.171\ln(x) + 6.891$	0.36
TSL A 5mm	$y = 0.943\ln(x) + 8.473$	0.89
TSL B 1mm	$y = 0.253\ln(x) + 7.575$	0.84
TSL B 3mm	$y = 0.560\ln(x) + 6.348$	0.99
TSL B 5mm	$y = 0.236\ln(x) + 7.094$	0.53
TSL C 1mm	$y = 0.876\ln(x) + 6.289$	0.92
TSL C 3mm	$y = 0.722\ln(x) + 6.485$	0.68
TSL C 5mm	$y = 0.218\ln(x) + 8.056$	0.54

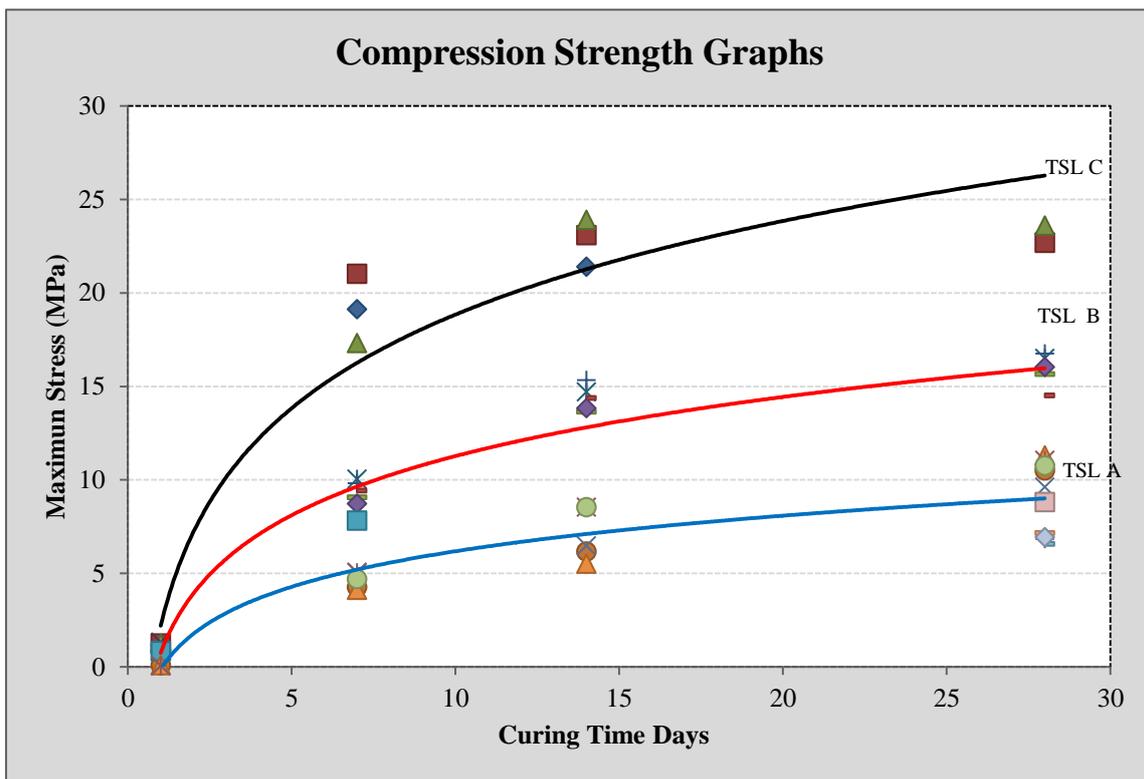
Figure 3.9 Compression strength development over curing time

Curing Time	Curing Time (Days)				Strength
	1	7	14	28	
Liner TSL A	0.1	4.6	7.0	8.9	Mean MPa
	0.0	0.4	1.4	1.9	Stdev MPa
	22	9	20	22	% Cov
TSL B	0.9	9.1	14.4	15.9	Mean MPa
	0.0	0.8	0.7	0.9	Stdev MPa
	3	9	5	6	% Cov
TSL C	1.2	19.1	22.8	23.1	Mean MPa
	0.1	1.9	1.3	0.5	Stdev MPa
	6	10	6	2	% Cov

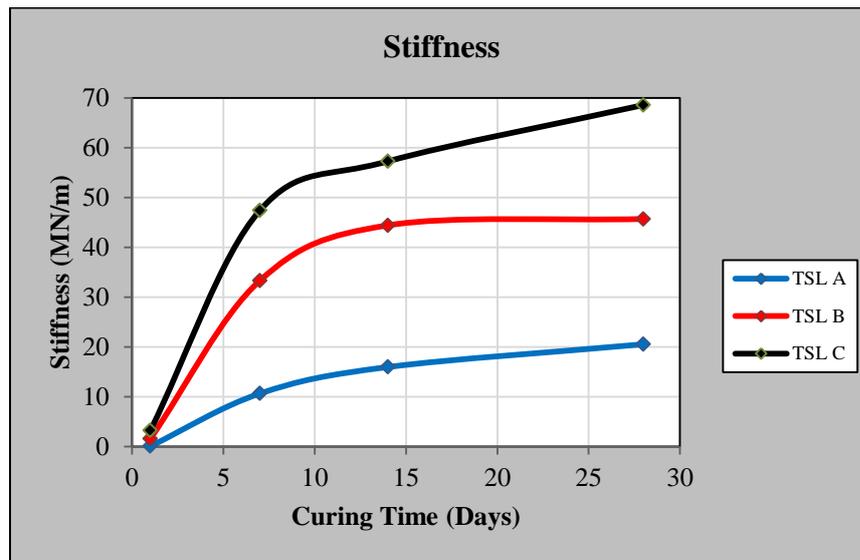
Figure 3. 10 Stiffness results

The results of the modulus of compressibility of the liner materials are not presented since strain gauges were not used to measure the deformation of the materials. However, material stiffness was determined using the deformation measurements from the MTS machine and assuming that the platens and components deformation is constant. Figure 3.10 show that TSL C displays the highest values followed by TSL B in terms of the material stiffness, however TSL A displayed very low values and this could be attributed to the moisture content in this cement based liner. Stacey (2001) highlighted that the stiffer the liner the more effective it is in inhibiting the initial rock movement, but once rock movement has started, the liner can no longer offer any support.

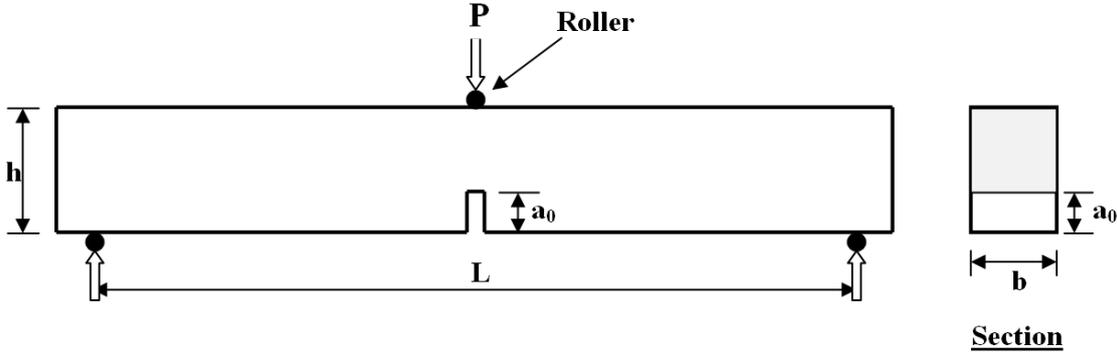
Figure 3. 11 Bending Test set up after (Vesel ý, 2007)

The three-point bending flexural test was carried out in two sets of experiments. Firstly it was performed on rock specimens with 10mm “cracks” a_0 as shown in (Figure 3.11), and secondly it was done on rock specimens without a crack. The tests were performed using the MTS machine at a loading rate of 0.01mm/sec. The liner was applied on one side of the rock specimen with a 10mm crack depth. A perspex glass 3mm thick was used to guide the thickness of the applied liner. TSL A, B, C and D were used for the bending tests. Exadaktylos *et al* (2001) suggests that in three point bending both the bending moment and the tensile stress reach maximum value immediately beneath the point of load application and consequently the crack starts at specimen mid span. The test was also used to investigate the effect of penetration of the liner into the cracks for rock support.

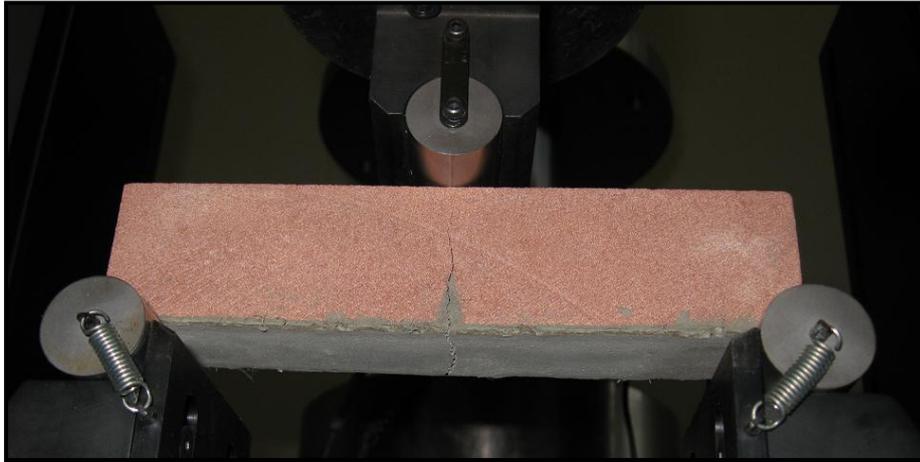
Figure 3. 12 Failed Sandstone Sample

Flexural strength is measured in terms of stress, and the value represents the highest stress experienced on the outer surface of the material at its moment of rupture (Figure 3.12). Hence, the test is designed to investigate the effect of the liner on the outer surface of the rock beams.

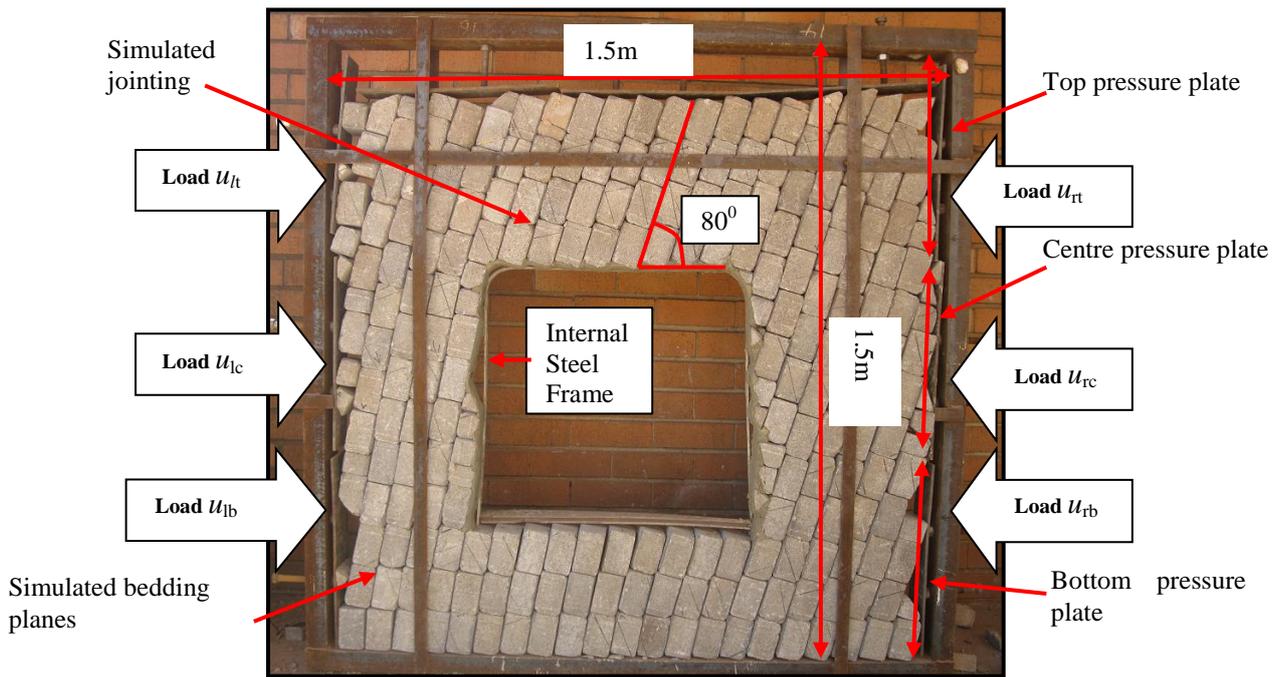
Figure 3. 14 Positions of applied load and deformation measurements

All tunnel model tests were carried out with horizontal loading (uniaxial loading) so that tunnel squeezing conditions would be realized. Loading in the horizontal direction was to allow for sliding along the simulated bedding planes to take place. Loading was done by displacing steel pressure plates using bolts, and the magnitude of the load was not measured. There were three pressure plates on each side of the frame where load was applied, that is the top, centre and the bottom (Figure 3.15). Each plate was loaded by turning two bolts 360⁰ starting with the right hand side centre plate followed by the top plate and the bottom plate was last. The same sequence of loading was used starting from the right hand side to the left for all liners and bedding orientations. The applied deformations on the pressure plates were measured at six fixed positions for all tests (u_{rt} , u_{rc} , u_{rb} , u_{lt} , u_{lc} and u_{lb}) between the pressure plates and the model steel frame using the vernier callipers on each successive loading (Figure 3.14 and 3.15). The reference measurements were taken before removing the internal steel frame that supported the tunnel during the curing period.

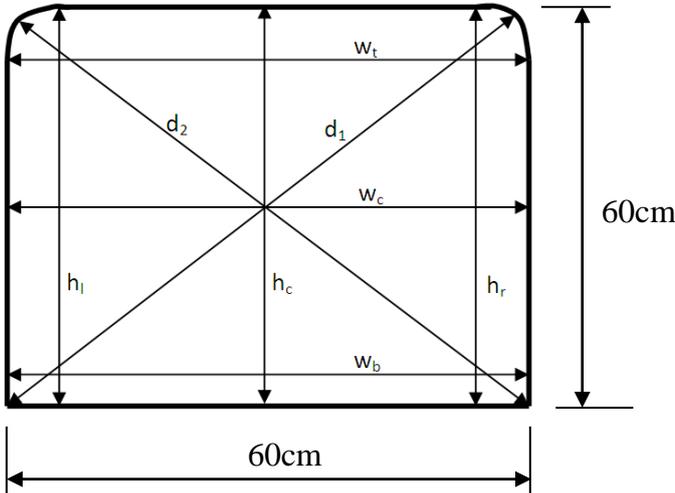
h_r, h_c, h_l = height measured at the right hand side, centre and left hand side

Figure 3. 16 Parameters that were measured inside a TSL supported tunnel

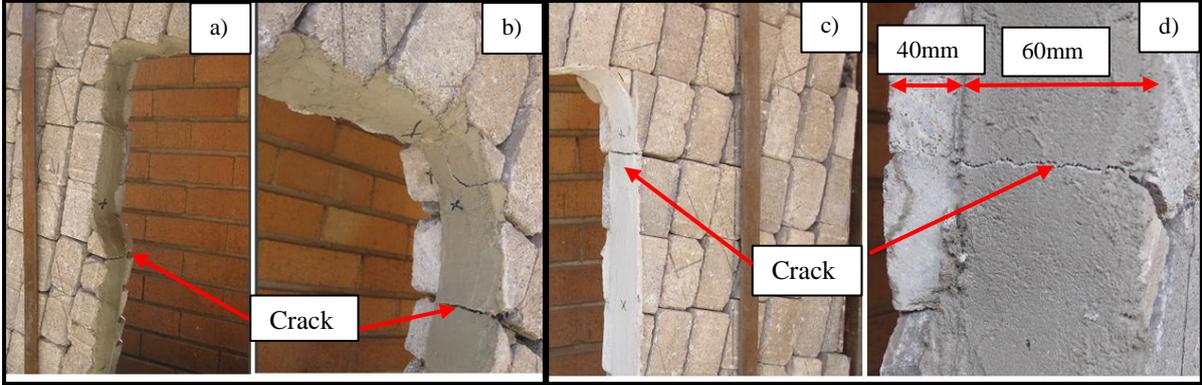
Figure 3. 17 Crack location a), b), c) and d)

orientation. The importance of this assessment was to show how liner failure influences the stability of the model tunnel as a whole and this will be covered in the discussion of the physical model.

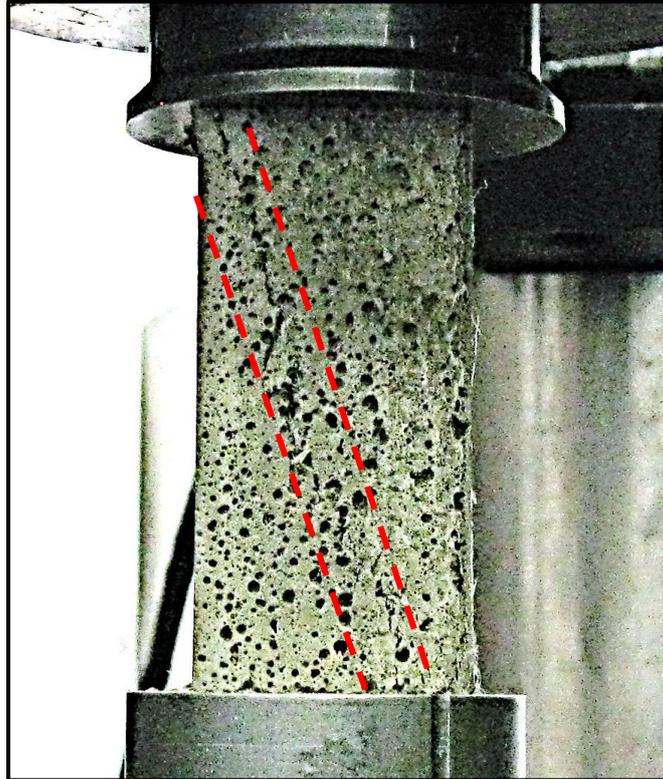
Figure 4. 1 TSL A Shear failure

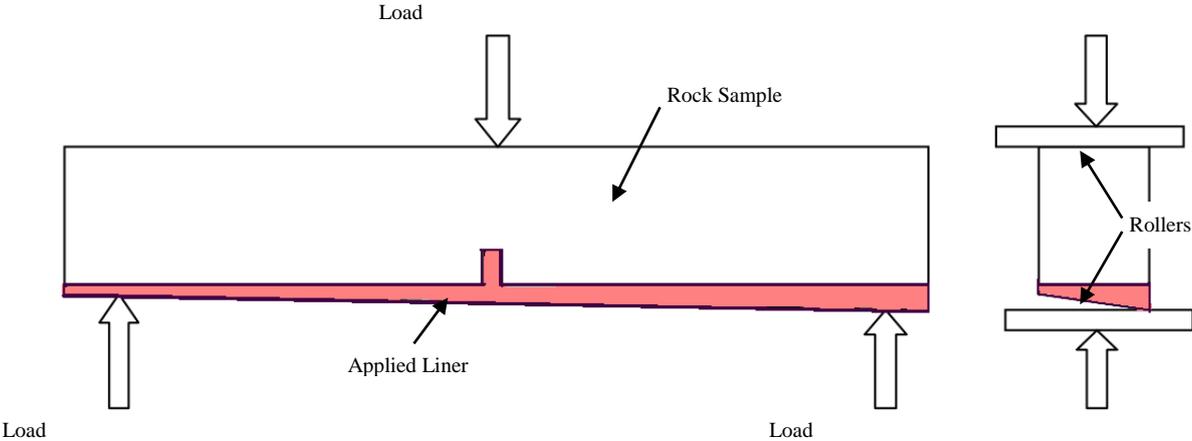
Figure 4. 2 Exaggerated Eccentric Loading

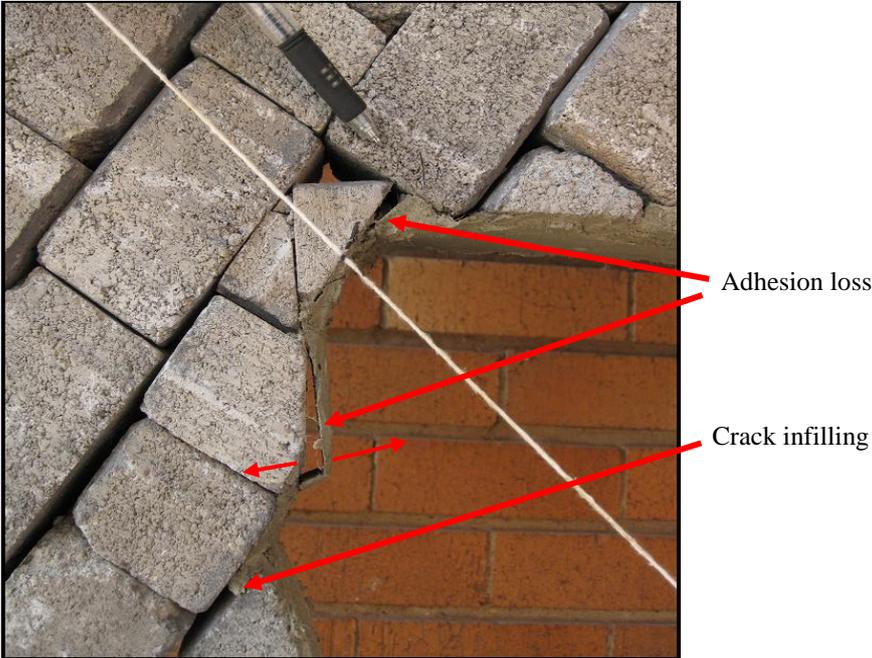
Figure 4.3 illustrates the adhesion loss where the liner is very thin, in conjunction with the apex of the block which is supportive of the failure mapping done by Malmgren *et al* (2005) on shotcrete linings.

Figure 4. 3 Adhesion loss at the corner of the tunnel

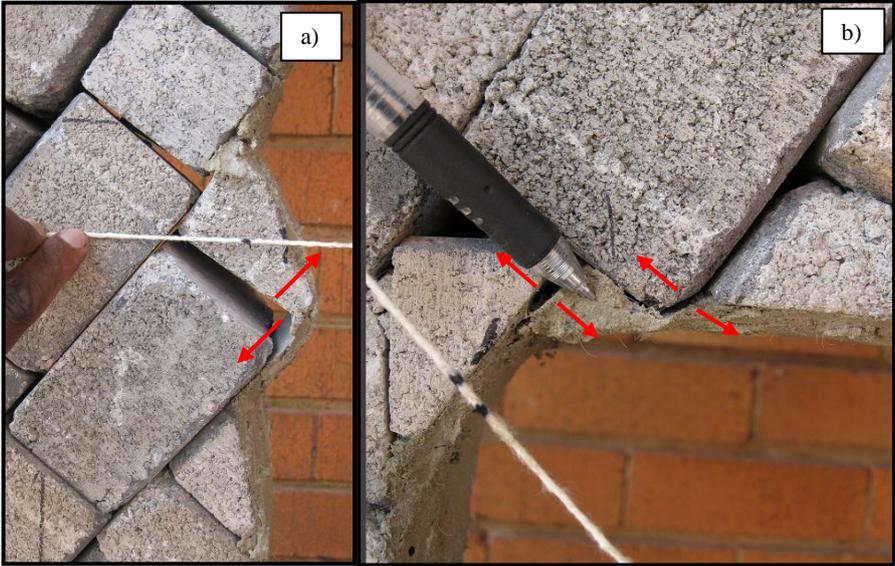
Figure 4.4 a) and b) show the types of adhesion failure that were observed. Liner A experienced adhesion failure more frequently than the other liners and that could have been due to the quality of the liner, which fell into the weak category. However, despite adhesion loss in some highly stressed areas, the liner continued to offer support to the model tunnel. As Ozturk and Tannant (2010) pointed out, where adequate adhesion strength exists, the liners have the potential to carry the load into the surrounding stable rock.

Figure 4. 4 Adhesion failure of the liner a)on the sidewall b) at the corner of the Tunnel

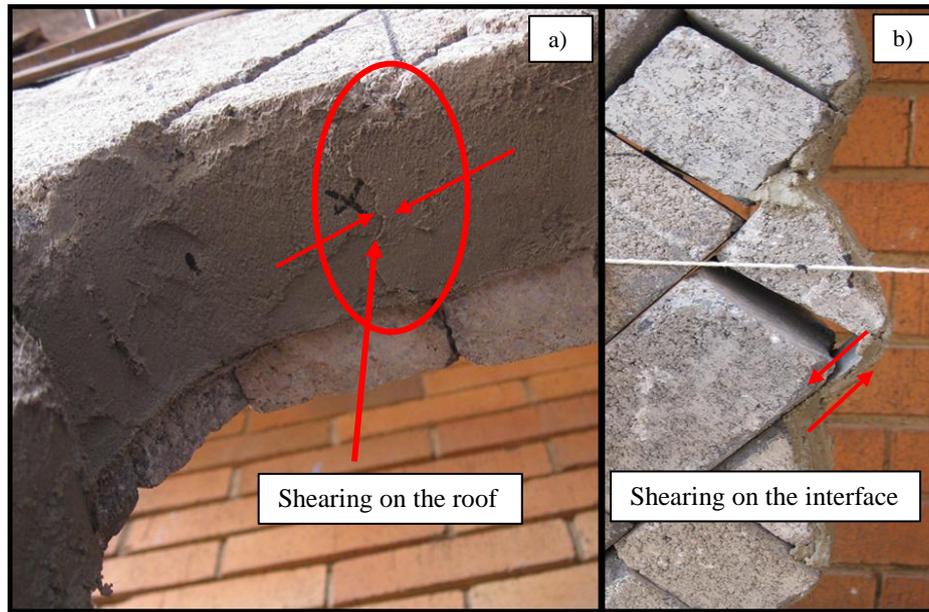
Figure 4.5 a) shows direct shearing on the left hand side corner of the tunnel roof. Figure 4.5 b) indicates shearing resulting in shear bond loss between the liner and the block.

Figure 4. 5 a) Shear failure at the top right hand corner of the tunnel b) Shear bond failure

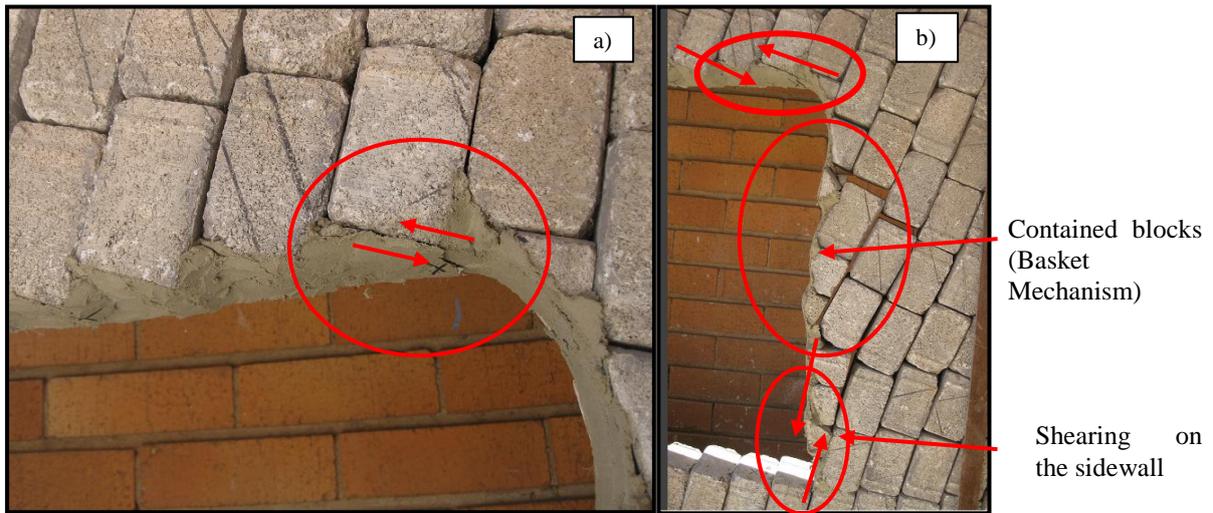
Figure 4.6 a) and b) show direct shearing on the right hand side of the tunnel corners. At the bottom of Figure 4.6b) the liner managed to resist shearing along the surface of the blocks giving rise to inward bending of the sidewall of the tunnel. Shearing was observed to be the result of concentrated loading on the liner by the movement of the blocks in opposing directions. Barrett and McCreath (1995) mentioned that direct shear only occurs when a strong adhesion bond is maintained. A “basket” was formed as described by Stacey (2001).

Figure 4. 6 Shearing of the liner at the right hand corner a) and b)

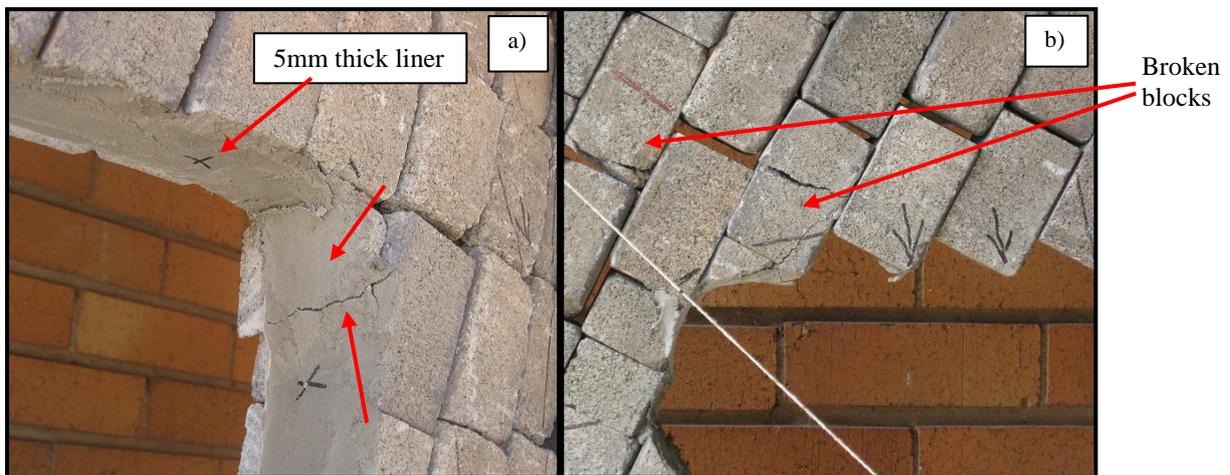
Also observed to be associated with shear were broken blocks that were located at the corner of the tunnel. Broken blocks were due to high horizontal loading above the tunnel (Figure 4.7b).

Figure 4. 7 a) Shearing and flexure at the right corner b) Block crushing at the left corner

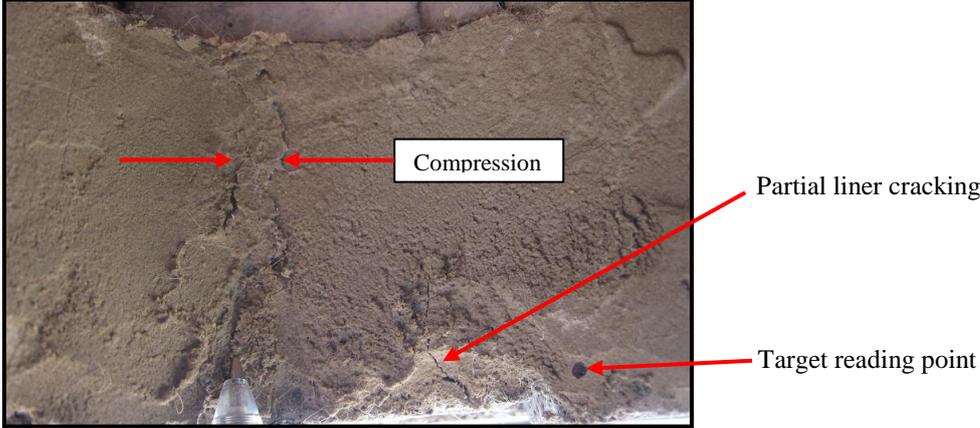
at the corners. This mechanism occurs at the haunches of the excavation as described by Stacey (2001) when strong adhesion strength is present between the liner and the blocks.

Figure 4. 8 Compression failure of the liner at the corner

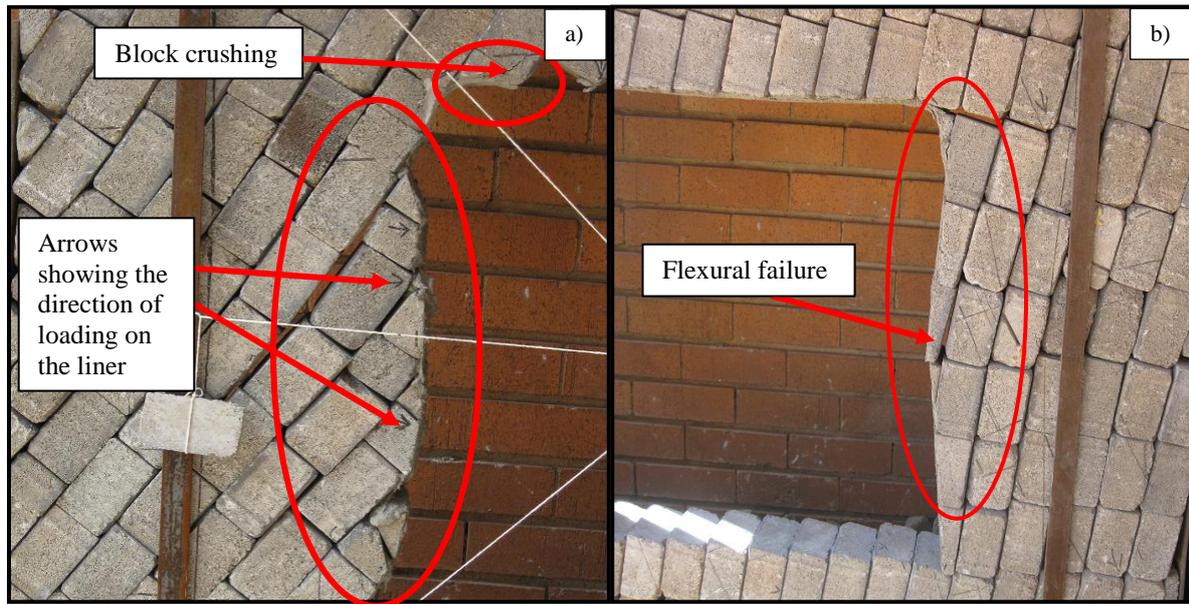
Flexural failure was manifest as a beam or basket of loose blocks resting on the liner. Two modes of flexural failure were observed. The first occurred on the sidewall of the tunnel as a result of excessive deformation as shown in Figure 4.9 a) and b). For sidewall flexural failure to occur, the liner has to prevent shear failure near the floor and roof of the tunnel so that the blocks in these regions are held in place. The overall failure mode of the sidewall blocks was toppling failure.

Figure 4. 9 Flexural failure a) on the left sidewall for 60⁰ b) on the sidewall for 80⁰ orientation

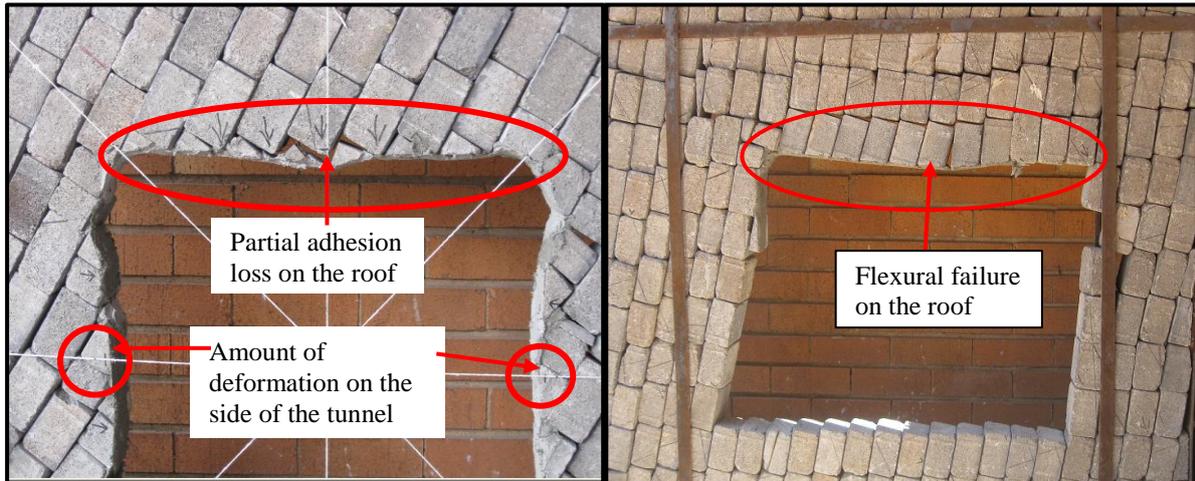
The second mode of flexural failure occurred in the roof of the tunnel. This mode of failure occurred when there was partial loss of adhesion at the centre of the tunnel, which could be a result of the squeezing of the tunnel, and adhesion being maintained at the corners as shown in Figure 4.10 a) and b). Roof flexural failure was observed to be a function of the orientation of the blocks. The orientation in Figure 4.10 a) fails earlier than the one in Figure 4.10 b). This could be caused by increased clamping between the blocks due to applied load across the tunnel (Figure 4.10 b) while in Figure 4.10 a) there is early failure as a result of higher shear stresses and sliding of blocks.

Figure 4.10 Flexural failure at the roof of the tunnel a) for 60° orientation b) for 80° Orientation
