Abstract

Thin spray-on liners (TSLs) are a type of surface rock support used in underground excavations, for maintaining stability at the excavation boundary. Different products are emerging in the market, while little is known about the mechanisms by which the liners support the excavation. There are no generally accepted tests which determine the performance of TSLs for rock support. In the research described in this dissertation, an attempt has been made to investigate the mechanisms of behavior of TSLs for rock support through laboratory tests. Brazilian indirect tensile strength tests, material compression tests, 3-point bending tests and physical model tests were carried out to investigate the performance and the characteristics of the liners for rock support. The Brazilian and the 3-point bending tests are new tests as far as TSL evaluation is concerned. The reviews of literature indicate that no similar testing appears to have been done previously.

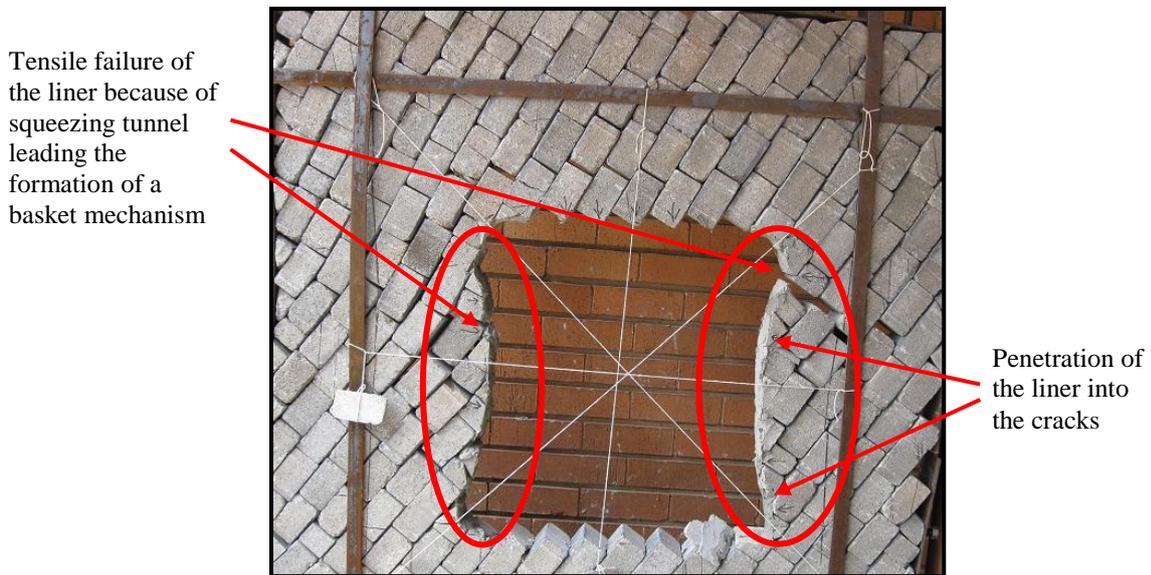
Figure 4.11 illustrates the tensile failure of the liner resulting from the distributed loading from the blocks on the liner. For this failure mechanism to occur it was observed that good adhesion existed between the blocks and the liner and that there was penetration of the liner into the cracks to prevent shear punching.

Figure 4.11 Tunnel squeezing before sidewall collapse

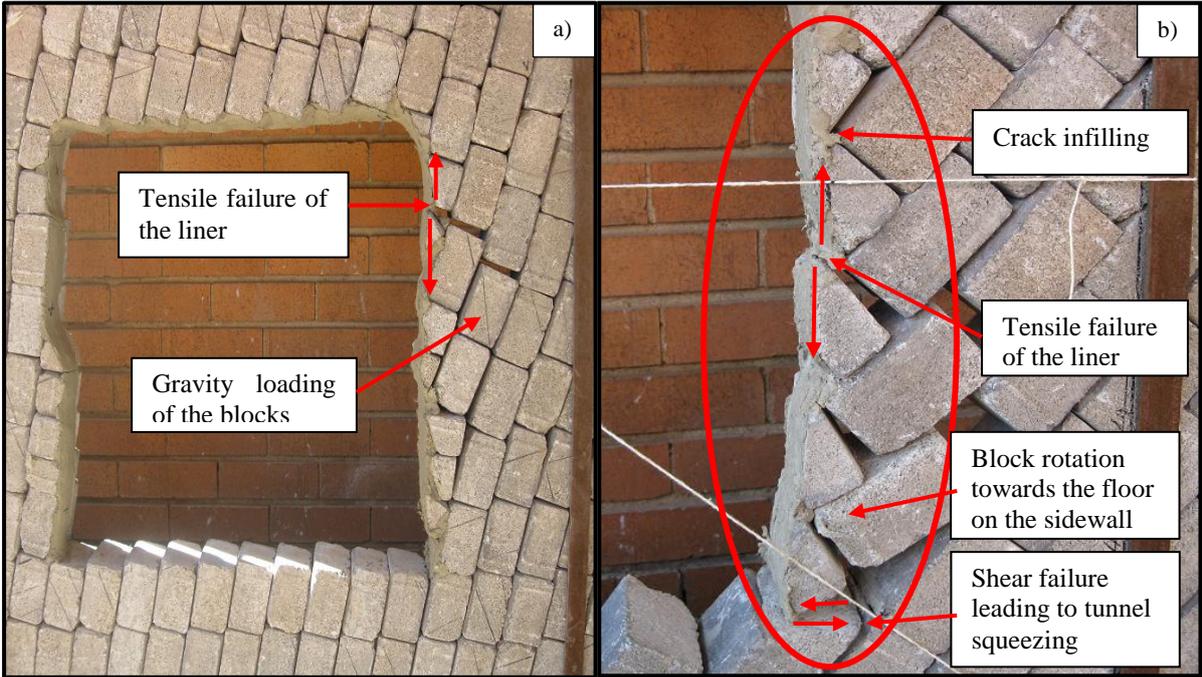
Figure 4.12 a) and b) illustrate the direct tensile failure of the liner observed. The liner fails as a result of gravitational loading of the blocks that slide downwards on the right hand side of the tunnel thereby transferring the load to the liner. In Figure 4.12b) it was a result of the initial shear failure at the base of the tunnel leading to rotation of blocks and downward sliding. Tensile failure of the liner was observed to be in areas where there was no liner in the cracks.

Figure 4.12 a) Tensile failure on the sidewall b) Tensile failure on the sidewall near the footwall

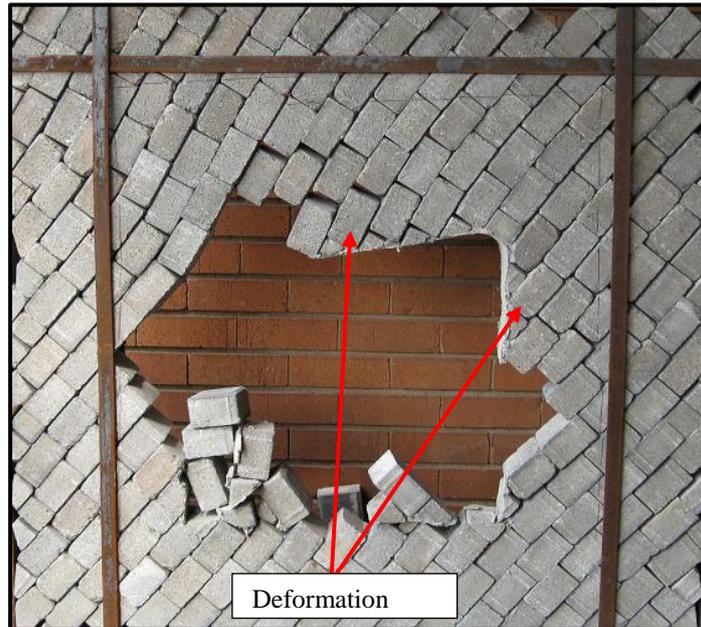
TSL A acting as a bridge in Figure 4.13, supporting failed blocks following shaking of the frame to destroy the model at the end of the test run. This Figure shows the ability of the liner material to offer support in squeezing conditions and to hold loose blocks together.

Figure 4. 13 Liner A supporting loose block in the roof of the tunnel at the end of test

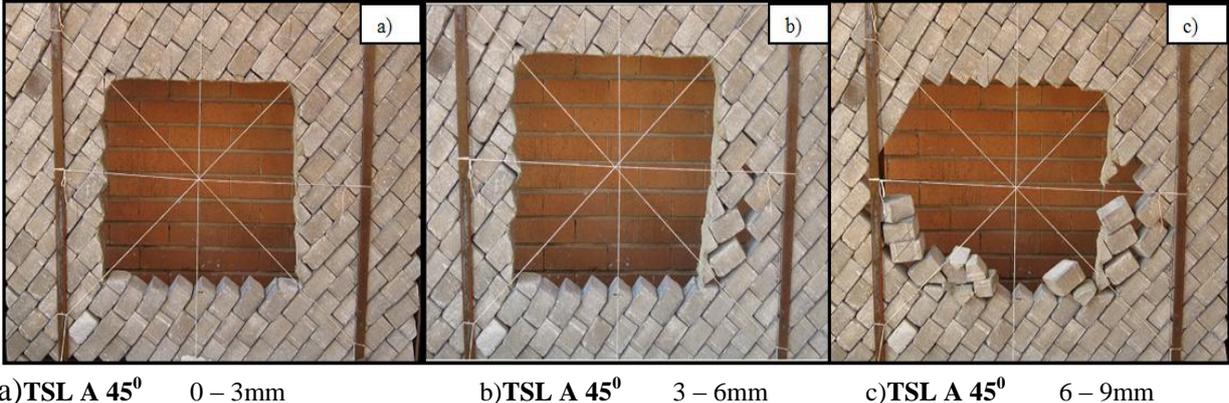
The applied liner shows that, it has the ability to support the tunnel to some extent after cracking has occurred. However, it fails easily following continued loading. The liner failure modes observed were a combination of tensile failure, adhesion failure and bending failure.

Figure 4.14 Loading Stages of the Tunnel Model for TSL A at 45° orientation a), b) and c)

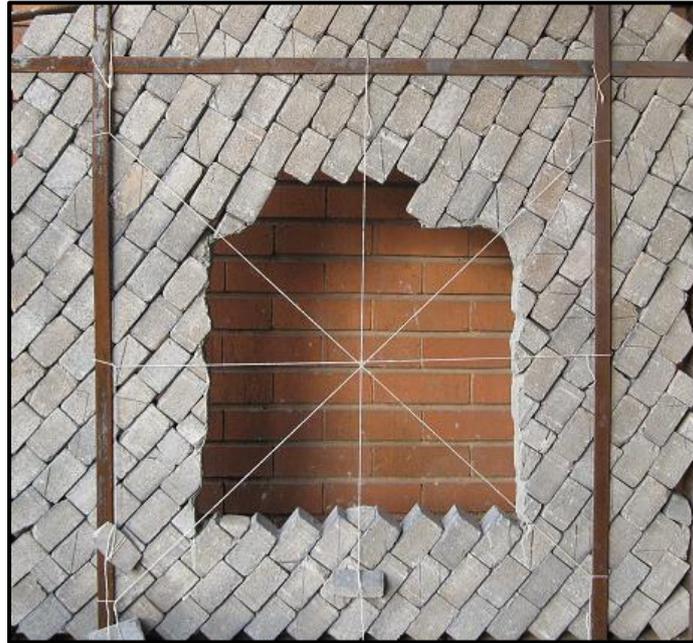
Figure 4.17 Loading Stages of the Tunnel Model for TSL B at 45⁰ Orientation

It was observed that for TSL B 45° orientation, unlike TSL A, cracking did not occur when the internal steel support frame was removed. The structure remained stable, however, cracking started on the right hand sidewall and roof collapse when applied deformation was in the range of 0mm to 3mm as shown in Figure 4.17. Sidewall collapse occurred when deformation was in the range 3mm to 6mm and total collapse when applied deformation was 9mm to 12mm. Compared with TSL A, it was observed that there was an increase in applied deformation before the first collapse occurs with TSL B.

TSL B 45⁰ 0 – 3mm

Similar modes of liner loading and failure were observed for TSL A and B, as well as the practical implications.

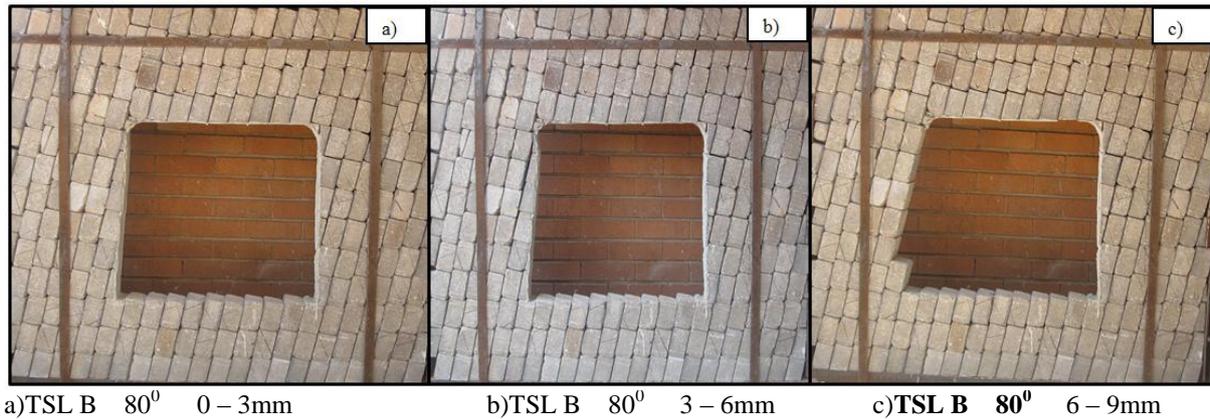
Figure 4.19 Loading Stages of the Tunnel Model for TSL B at 80° orientation a), b) and c)

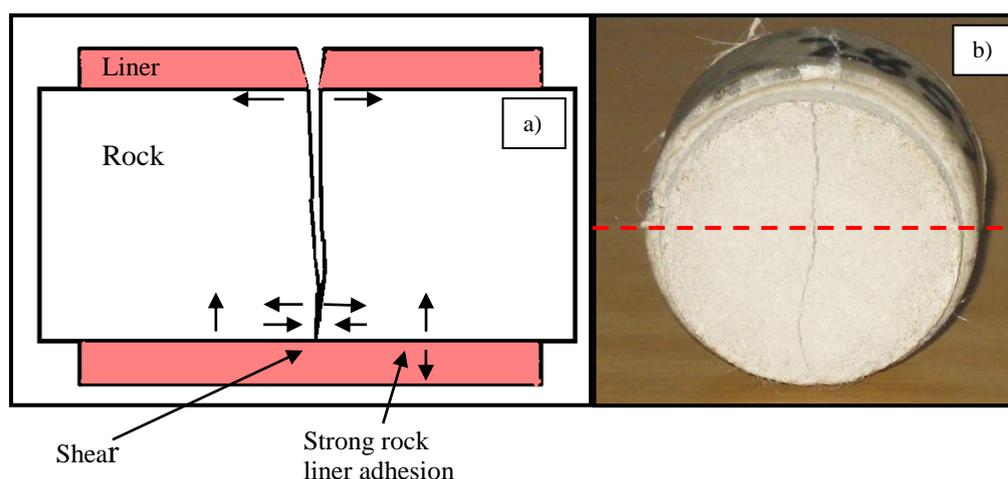
Figure 4.23 a) Basket and promotion of block interlock b) Section line on a Brazilian disc

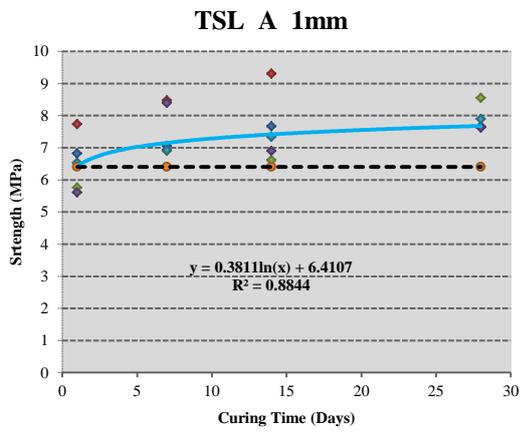
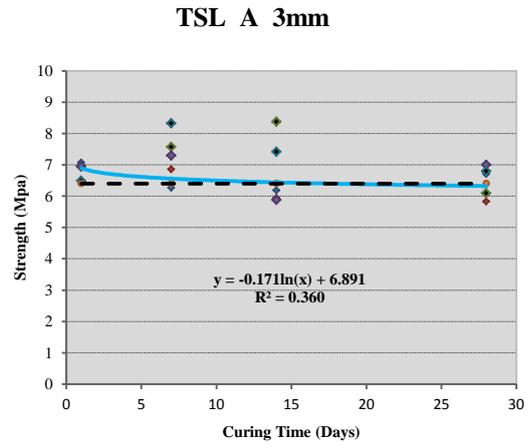
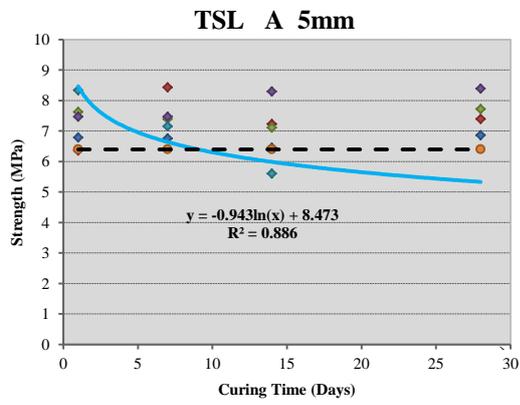
Figure A.1 TSL A Brazilian Test graphs a), b), c)

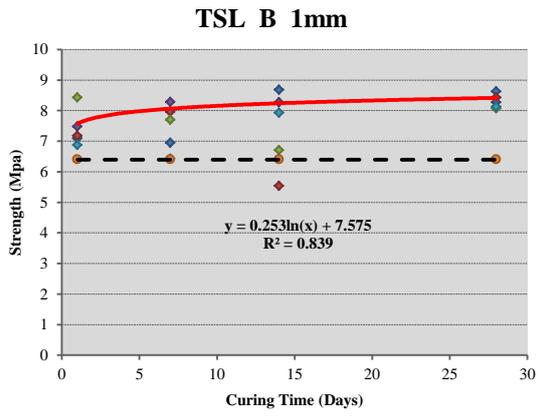
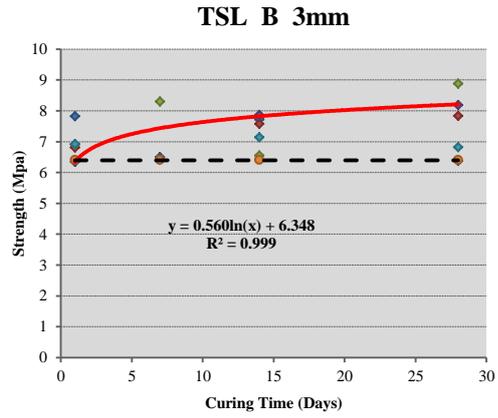
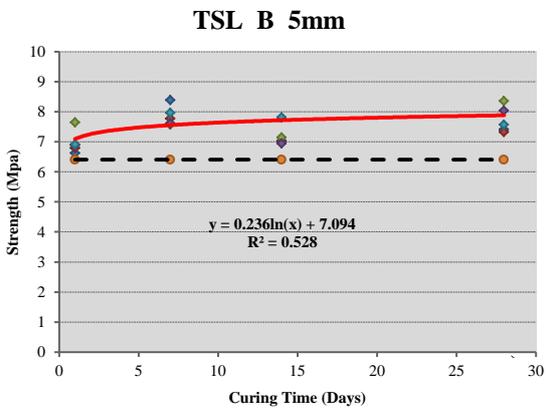
Figure A.2 Brazilian Test graphs a), b), c)

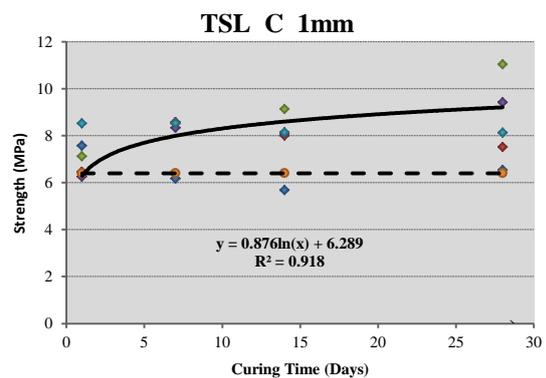
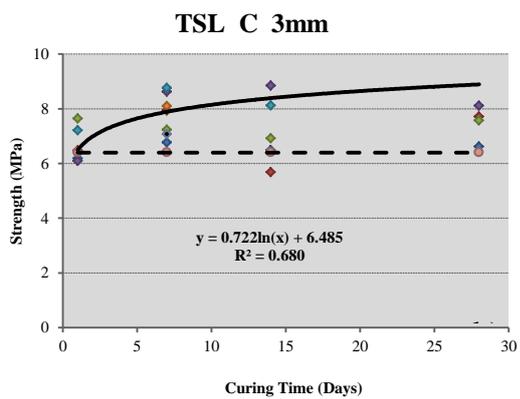
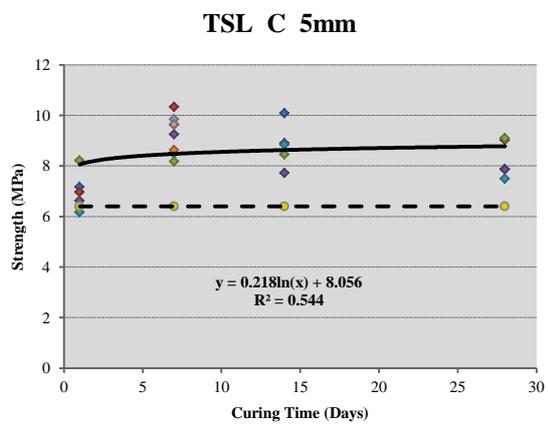
Figure A.3 Brazilian Test graphs a), b) and c)
