BUILDING CONDITION  
ASSESSMENT REPORT

**36 Boundary Rd, Isle of  
Houghton Office Park, JHB**

**Wits Health Consortium**

Document number: IOH Condition Assessment  
Revision: 1

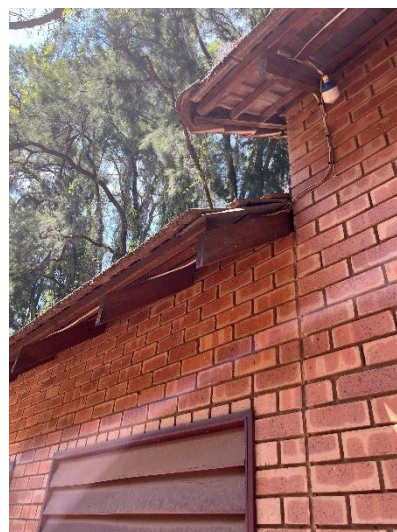
Photo 2

| Structural element | State of condition | Description |
|---|---|---|
| <b>Roofs</b> | 4 | Roof rafters appeared to be in an acceptable structural condition. Some tiles on the roofs were visibly shifted and the building manager noted issues of leaking in the area (see Photo 1 and 2) |

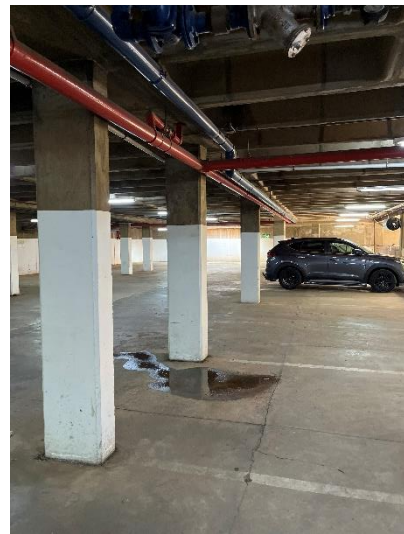
**Photo 6**

| <b>Structural element</b> | <b>State of condition</b> | <b>Description</b> |
|---|---|---|
| <b>Leaking pipes</b> | 4 | Pipes are leaking in the basement resulting in water ponding on slab. Pipes to be fixed to avoid damage to slab (see Photo 6). |

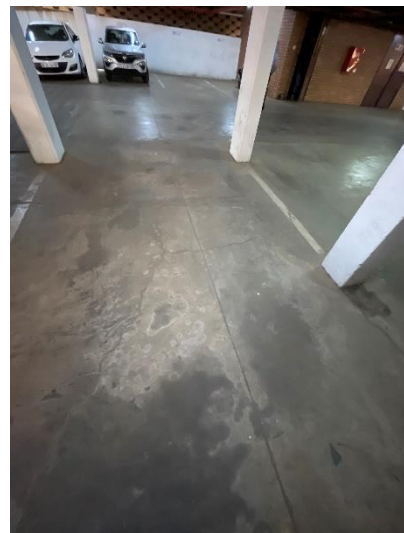
**Photo 8**

| <b>Structural element</b> | <b>State of condition</b> | <b>Description</b> |
|---|---|---|
| <b>Cracking around columns</b> | 4 | Basement screed is cracking around columns due to insufficient/improper joints (see Photo 8). Cracks should be sealed to avoid water damage to reinforcement in the slab. |

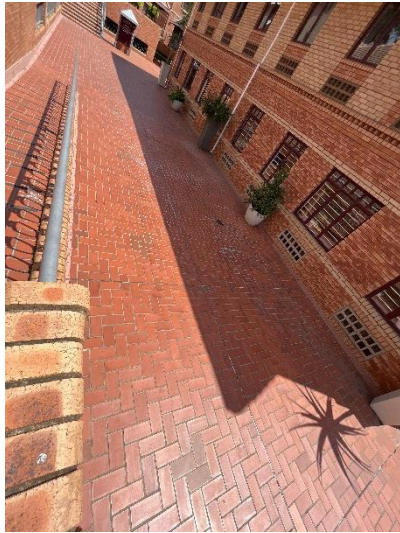
**Photo 11**

| <b>Structural element</b> | <b>State of condition</b> | <b>Description</b> |
|---|---|---|
| <b>Water issues in courtyard</b> | 3 | There appears to be signs of water ponding in courtyard which may be the result of block full bores in the area (see photos 11 and 12). Ponding results in water seeping through slab below resulting in concrete efflorescence as described in the previous point. Full bores need to be maintained to avoid ponding. The area may also require further waterproofing upon conclusion by specialist. Previous waterproofing has been done between the building face brick and the paving. The paving is porous rendering the previous waterproofing inadequate. Proper waterproofing would require the paving to be lifted with waterproofing being applied to the slab itself. |

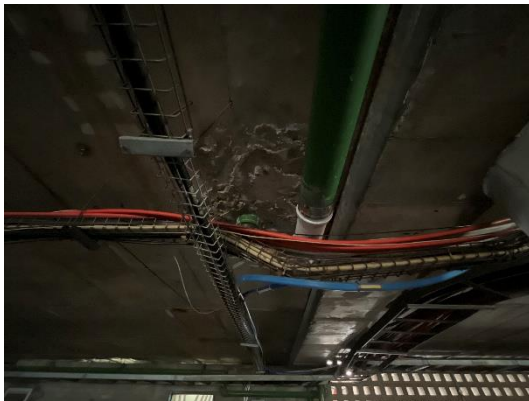
**Photo 13**

| <b>Structural element</b> | <b>State of condition</b> | <b>Description</b> |
|---|---|---|
| <b>Water damage on soffit of slab</b> | 4 | Some pipes are leaking resulting in water damage to the slabs in the basements (see Photos 13 and 16). Specialist to determine the cause of the leaks and repair to suit. |

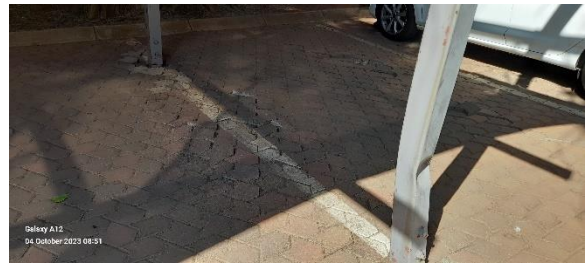
There are walkways and parking outside the buildings surfaced with block paving. In general, the paving look to be in good condition. There are minor settlement and tree uprooting of the paving in some areas. (see **Photos 9,10,11 and 12**).

**Photo 10: Uprooting of block paving on Harcourt 3 parking**

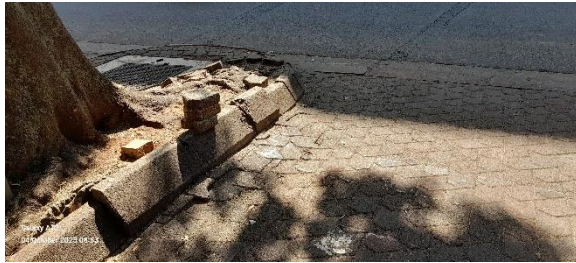
**Photo 11: Uprooting of block paving and kerbs on exit Harcourt 2 parking**

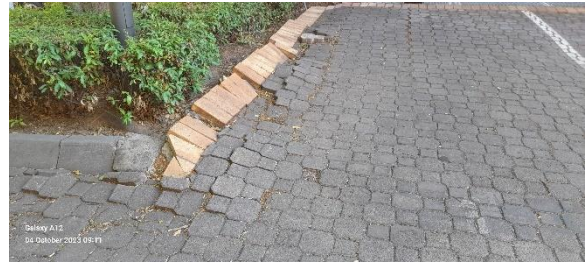
**Photo 12: Uprooting of block paving and kerbs on Old Trafford 2 parking**

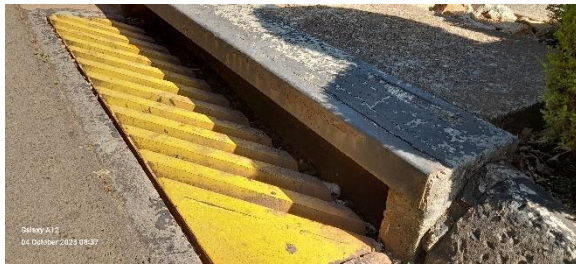
The cut-off drains located at the entrance of the basement parking look to be in good condition, but regular removal of leaves is required. There is a kerb inlet at the main entrance (on exit side) that is fully blocked with (see **Photo 13 and 14**). There is a stormwater manhole cover missing on the eastern side of Old Trafford 1 (see **Photo 15**).

**Photo 13: Kerb inlet fully blocked at the main entrance (on exit side)**

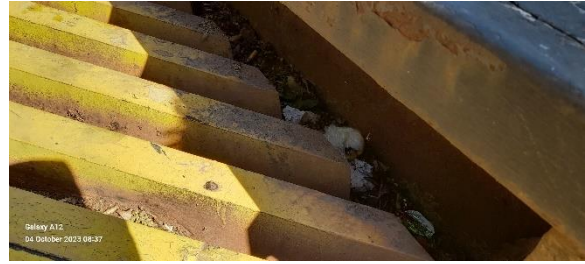
**Photo 14: Kerb inlet fully blocked at the main entrance (on exit side)**

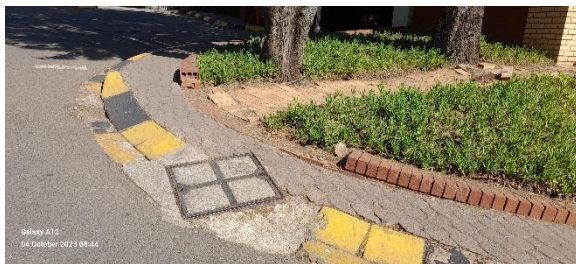
According to the maintenance team, there are two areas where the property experiences periodic sewer blockages. The first one is at the sewer manhole on the northern corner of Old Trafford 4 and this is caused by the intrusion of tree roots into the manhole (see **Photo 17**). The second, at the inspection eye (IE) at the entrance between Old Trafford 2 and 4 (see **Photo 18**).

**Photo 17: Sewer manholes between Old Trafford 4 and Parking Building that block periodically**

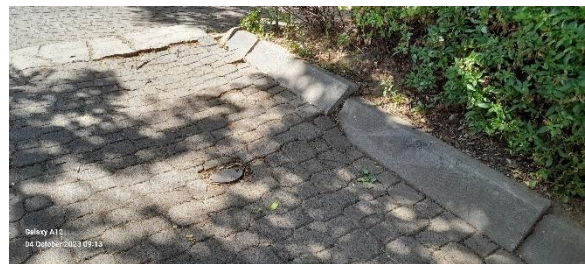
**Photo 18: Sewer IE between Old Trafford 4 and 2 that blocks periodically**

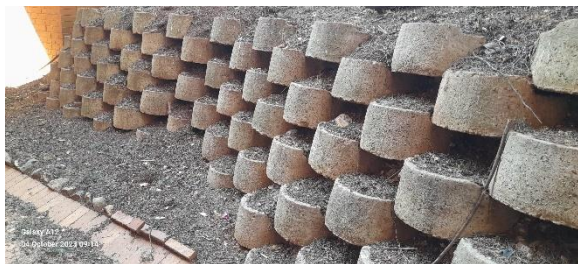
There are block retaining walls located on the northern, southern side of each building and eastern side of Old Trafford 1. There are no noticeable movements on the retaining walls, except for the damaged block wall around the tree on the northern side of Old Trafford 3 damaged by tree roots (see **Photo 23 and 24**).

**Photo 23: Loffelstein retaining wall**

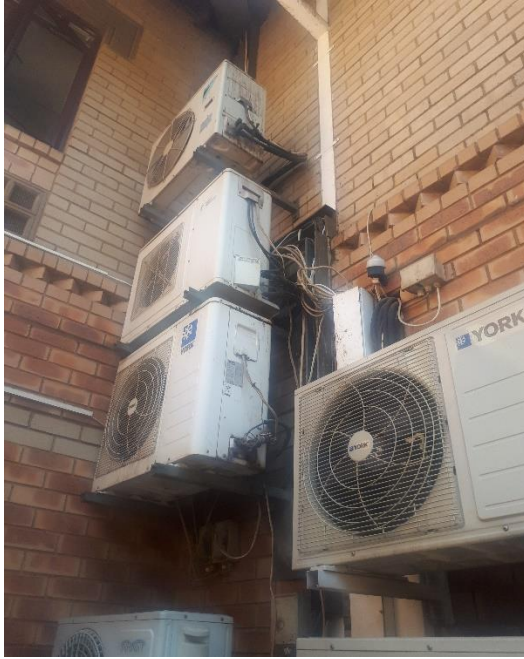
**Photo 5: Photo showing typically aged split units installed against Harrow Place façade serving areas not catered for, by the console units**

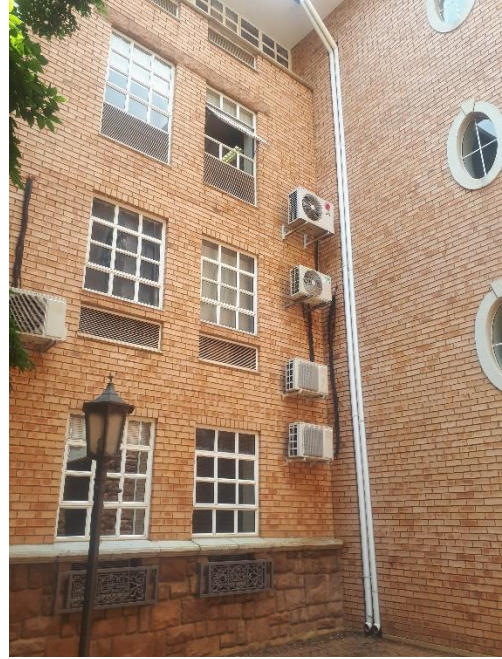
**Photo 6: Photo showing typical split units installed against Old Trafford façade wall in inaccessible location making maintenance problematic**

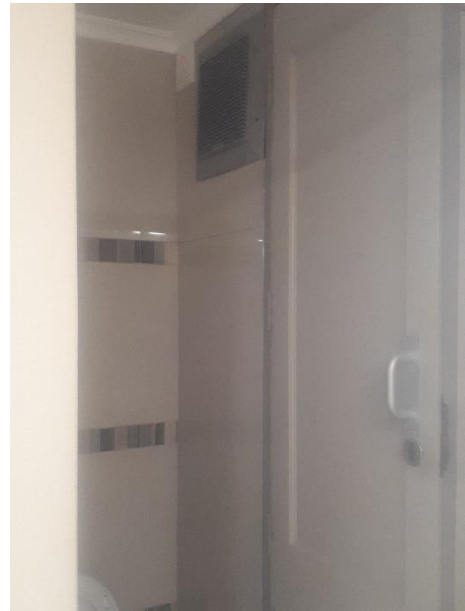
**Photo 8: Photo showing typical toilet wall mounted toilet extract fan system. (Extraction lacking in disabled toilets)**

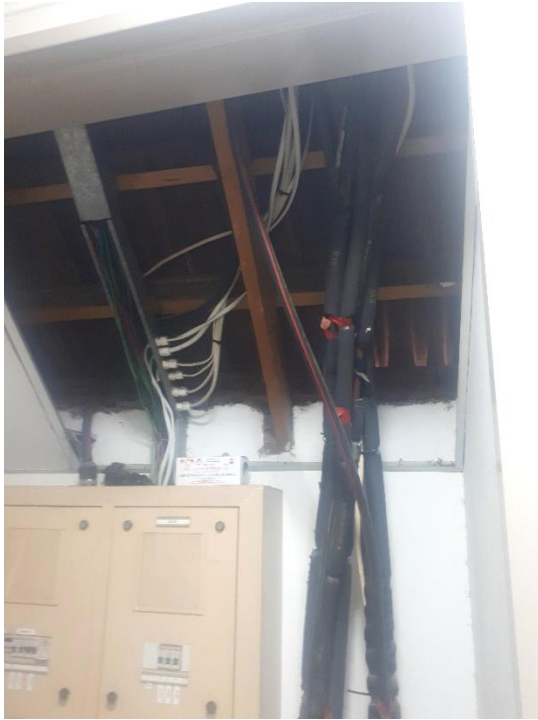
**Photo 9: Photo showing typical upper level at Harrow court ceiling void (note no roof insulation under roof tiles) with refrigeration piping rising in electrical shaft to split units on floor.**

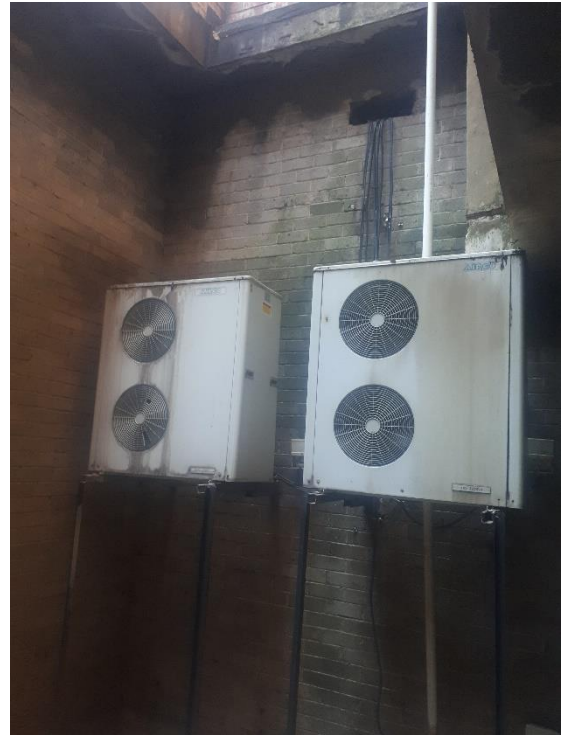
**Photo 13: Photo showing redundant split unit condensers at Old Trafford complex. Units to be removed from site.**

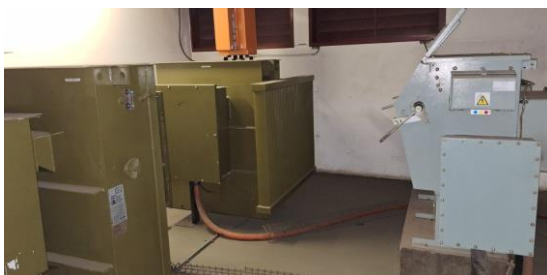
The transformers are of the sealed ONAN (oil natural air natural) type. Although the transformers are old, they appear to be in a reasonably good condition. No oil leaks were observed and the oil levels were correct. The year of manufacture of the transformers is 1993.

**2 x 500kVA ONAN transformers**

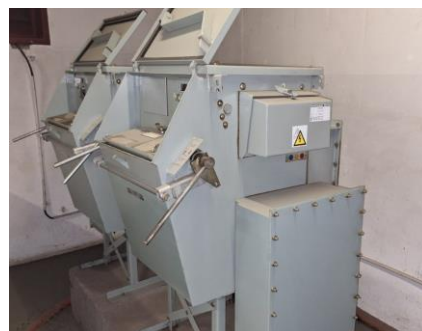
This substation is fitted with an 11kV panel with 2 oil-filled fuse switches for the 500kVA transformers. Although the switchgear is old technology it appears to be in a reasonably good condition. No oil leaks were observed and the oil levels were correct.

**Fused 11kV oil switches for transformers**

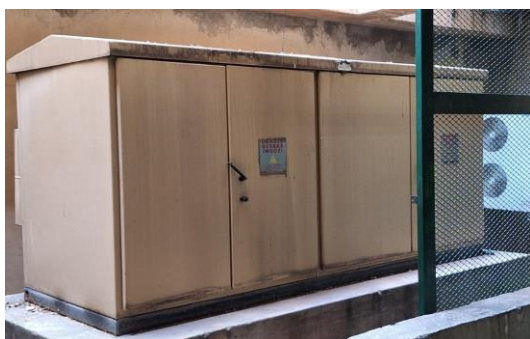
The minisub transformer is of the sealed ONAN type. Although the transformer is old, it appears to be in a reasonably good condition. No oil leaks were observed and the oil level is correct. The year of manufacture of the transformers is 1997.

**800kVA minisub**

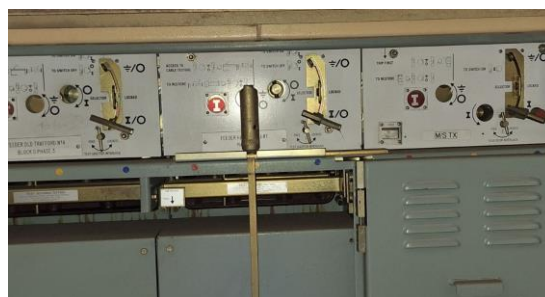
The minisub is fitted with an 11kV K3 switch, as was the standard with minisubs of the era. The 11kV switch is of old technology but appears to be in reasonably good condition.

**11kV switchgear inside minisub**

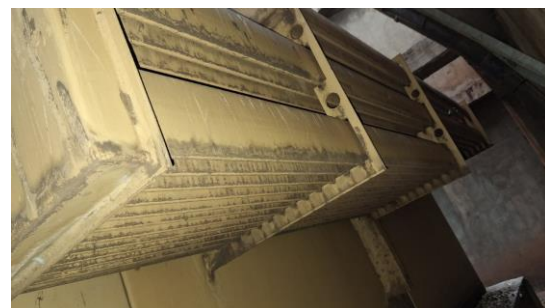
The minisub transformer is of the sealed ONAN type. Although the transformer is old, it appears to be in a reasonably good condition. No oil leaks were observed and the oil level is correct. The year of manufacture of the transformers is 1997.

**Transformer cooling fins. No oil leaks were observed.**

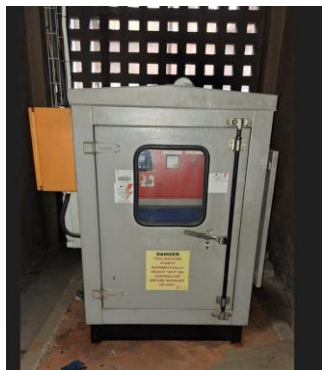
Of concern is the generator room size. The room is not sufficiently sized which makes servicing problematic and safety clearance is also not sufficient. No fused link to activate a diesel shut-off was observed and should be implemented.

**Sound attenuated enclosure**

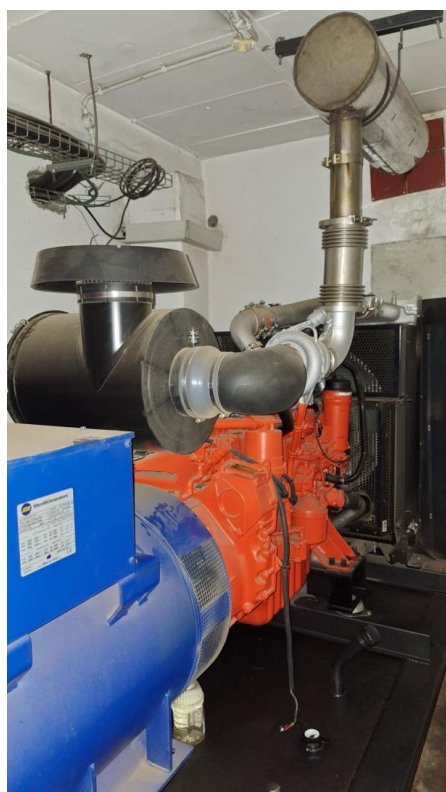
Of concern is the generator room size. The room is not sufficiently sized which makes servicing problematic and safety clearance is also not sufficient. No fused link to activate a diesel shut-off was observed and should be implemented.

The condition of the generator appears to be in a reasonably good condition, with no oil or diesel leaks observed.

**300kVA generator**

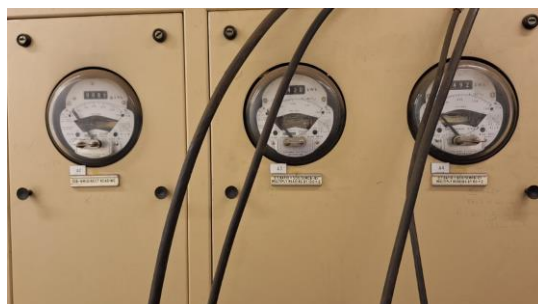
The switch gear inside the panel is old and some replacement may be required. Some sub-metering is in place. These are old electro-mechanical meters without any interfacing capabilities. These types of meters have become obsolete.

The panel is in a fair condition and in need of maintenance. Non-connected earth wires are concerning and should be rectified urgently.

**Harrow Court Building  
Main LV Panel: Metering**

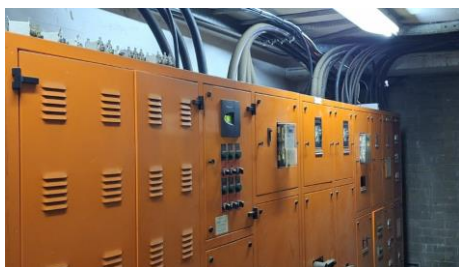
The switch gear inside the panel is reaching its end of life and some replacement may be required. Some sub-metering is in place. These are old meters with limited interfacing capabilities. These types of meters have become obsolete.

The panel is in a reasonable condition, but in need of maintenance.

**Old Trafford, Building 2  
Main LV Panel**

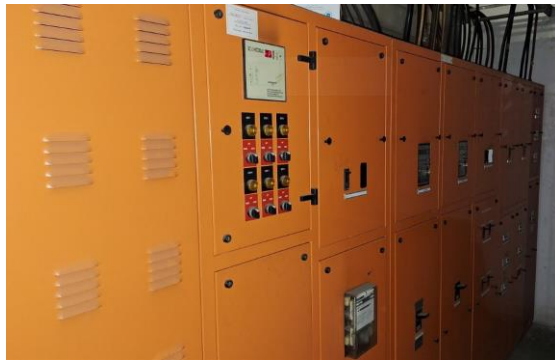
The switch gear inside the panel is reaching its end of life and some replacement may be required. Some sub-metering is in place. These are old meters with limited interfacing capabilities. These types of meters have become obsolete.

The panel is in a reasonable condition, but in need of maintenance.

**Old Trafford, Building 3  
Main LV Panel**

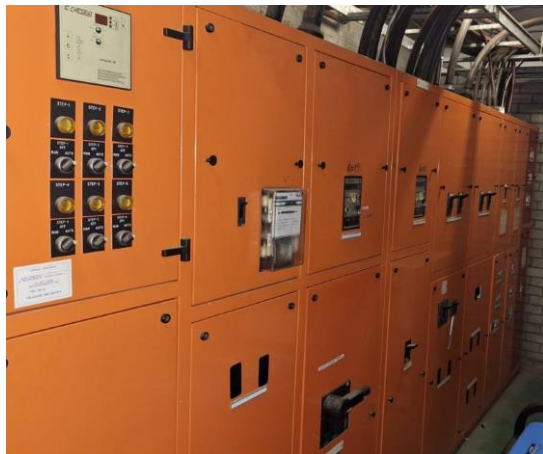
The switch gear inside the panel is reaching its end of life and some replacement may be required. Some sub-metering is in place. These are old meters with limited interfacing capabilities. These types of meters have become obsolete.

The panel is in a reasonable condition but in need of maintenance.

**Old Trafford, Building 4  
Main LV Panel**

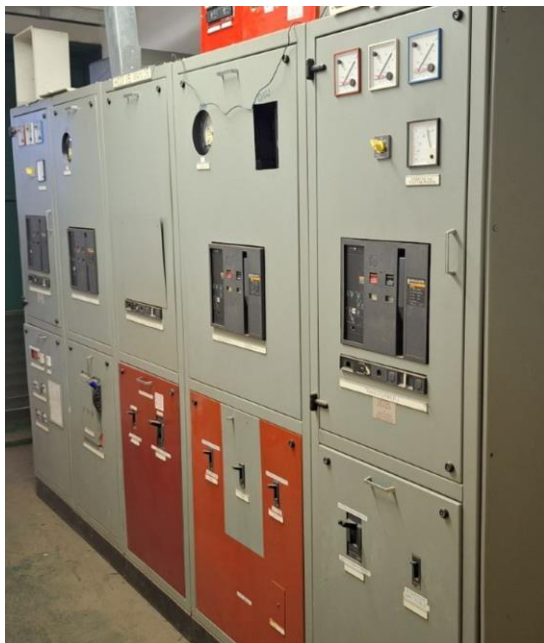
The switch gear inside the panel is old and some replacement may be required. Some sub-metering is in place. These are old electro-mechanical meters without any interfacing capabilities. These types of meters have become obsolete.

The panel is in a reasonable condition but in need of maintenance.

**Wild Views, Building  
Main LV Panel**

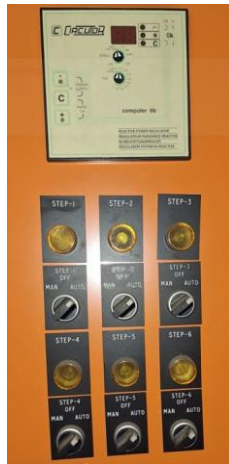
All main LV panel at Old Trafford have been provided with PFC. No other PFC is installed on the site. The PFC equipment needs to be serviced, as many are manually set to “off”, assuming that there might be a failure of some capacitors.

**Old Trafford, Building 4  
PFC not operational, no display indication by  
controller**

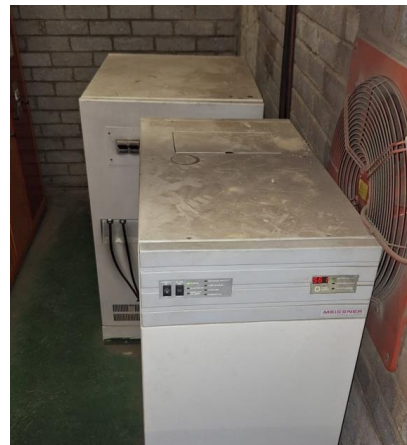
All main LV panel at Old Trafford have been provided with UPS units. No other UPS units are installed on the site. The UPS units need to be serviced, and possibly have to be provided with new batteries. Many UPS units are not operational and have alarm conditions. might be a failure of some components.

**UPS units with clear signs of lack of  
maintenance**

The UPS units are of old technology and the entire replacement thereof is recommended.

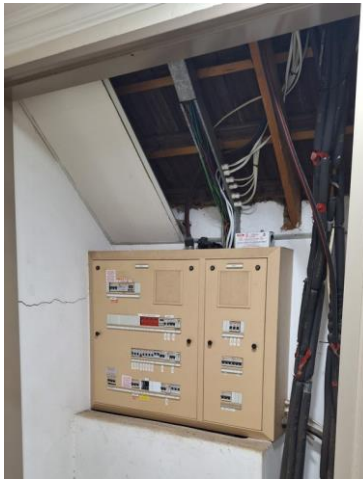
**Sub-main LV panel inside roof cupboard, creating excessive heat exposure.**

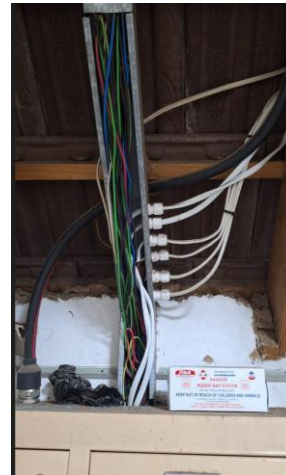
**Wireway to DB, without cover**

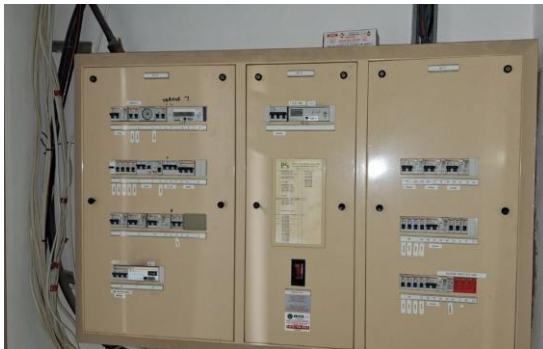
**Wiring inside DB cupboard, without wireways**

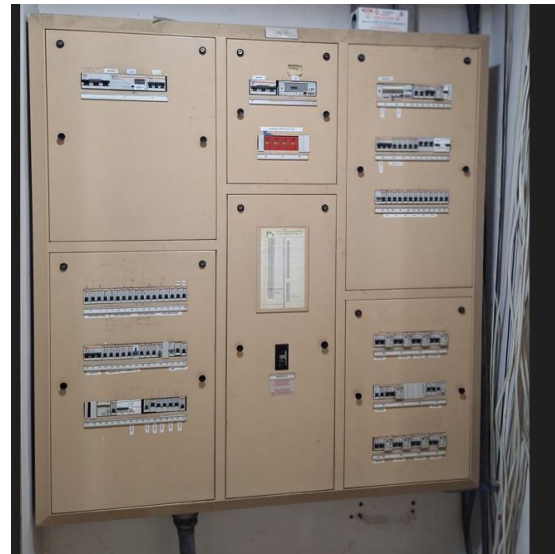
**No wireway and unsupported wiring**

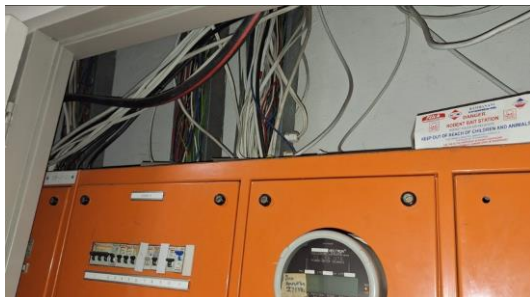
**No wireway and unsupported wiring**

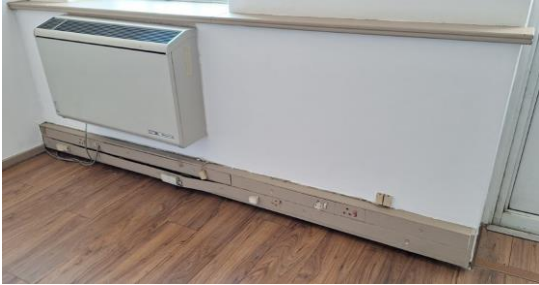
| <p><b>Old power skirting inside tenant areas</b></p> | <p><b>Obsolete power skirting inside tenant area</b></p> |

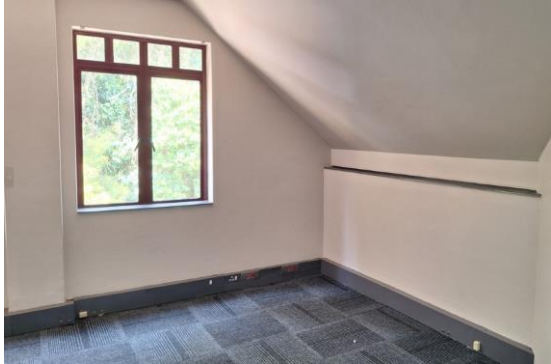
Power skirtings vary from tenant-to-tenant area of which some are not available in the market anymore.

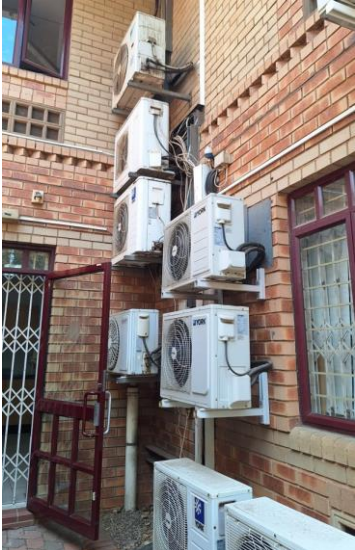
| <p><b>Untidy and non-compliant wiring to tenant HVAC units</b></p> | <p><b>Obsolete fluorescent lighting inside tenant area</b></p> |

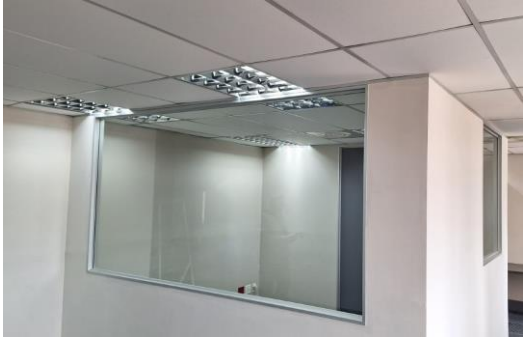
Tenant lighting is mostly of the old fluorescent tube type of lighting and is not of the latest energy efficient LED-type of lighting.

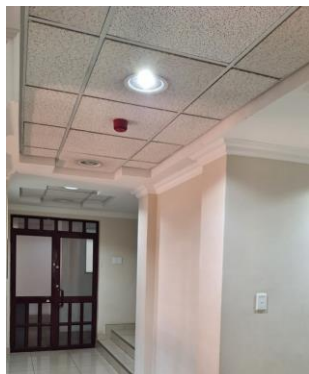
**LED downlights in lobby**

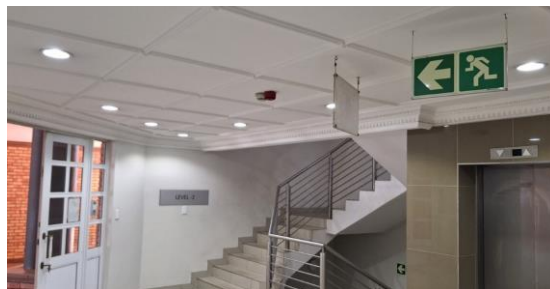
**LED downlights in lobby**

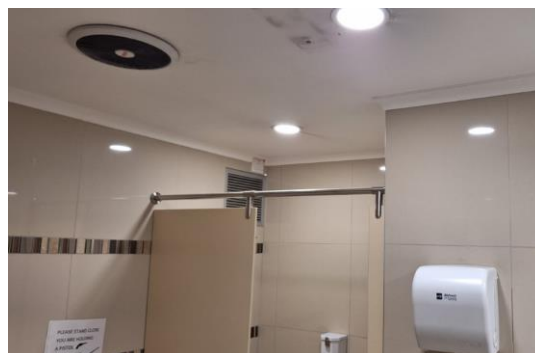
**LED downlights in toilets**

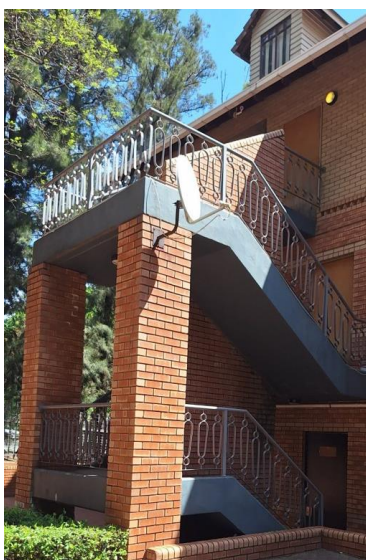
Each building has been fitted with external lights in courtyards, staircases and for balconies. The lights are old (but suitable for the building architecture). They have not been fitted with LED energy efficient lamps.

**External staircase lighting**

- ▶ All undercover parking lights need to be replaced with new energy efficient linear light fixtures.
- ▶ All external and pole lights need to be converted to LED lighting.

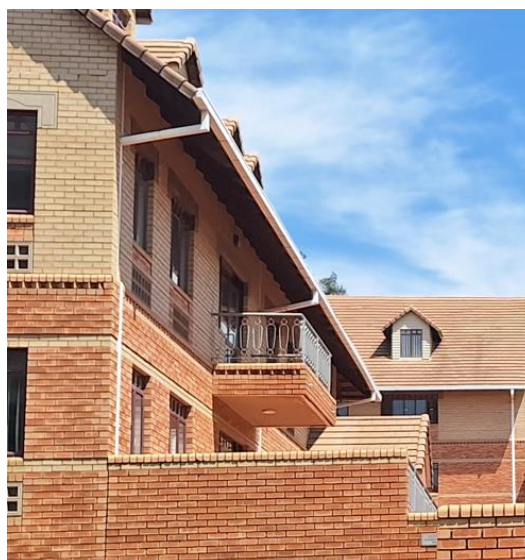
**Balcony lights**

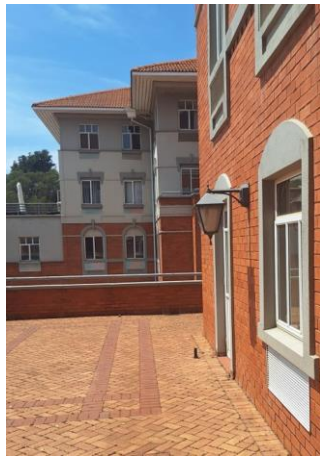
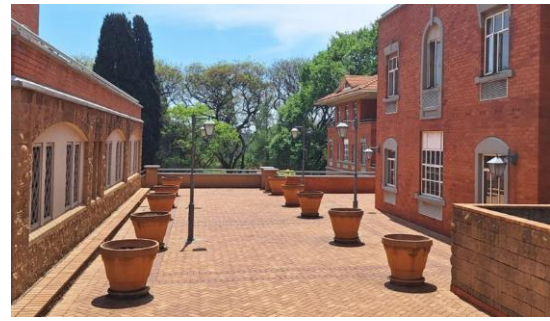
**Courtyard lighting**

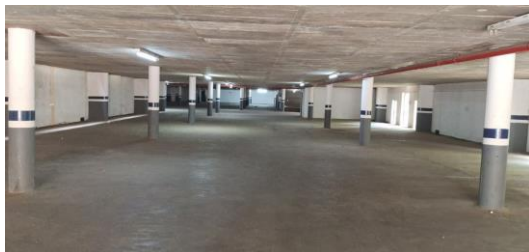
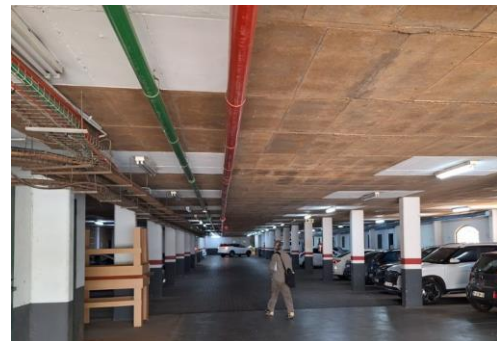
All parking areas are fitted with linear fluorescent light fittings, which have been retrofitted with linear LED tubes. All these light fixtures are problematic throughout the entire development as they continuously flicker.

Retrofitting LED tubes to old fluorescent light fixtures is not an acceptable engineering solution and continuous surges, due to load shedding caused failures of components.

**Typical linear light fixtures in undercover parking areas**

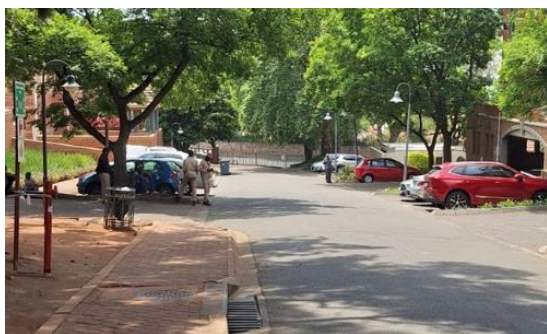
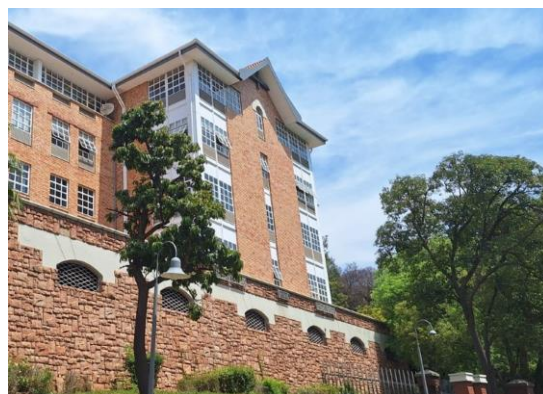
Road light fixtures consist of decorative pole mounted light fittings, complementing the architecture of the buildings. The light fixture lamps are of the old CFL type and have now become obsolete.

**Typical road lighting installation**

It is recommended that these light fixtures are fitted with LED lamps, retaining the “look-and-feel” of the office park architecture.

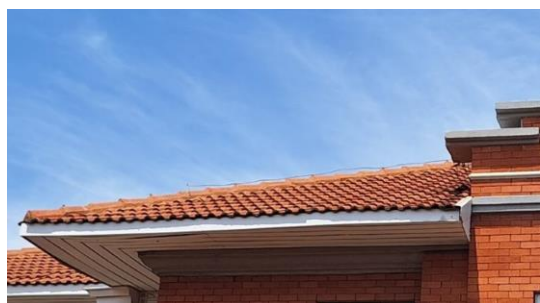
**LPS conductors on ridge of tiled roof**

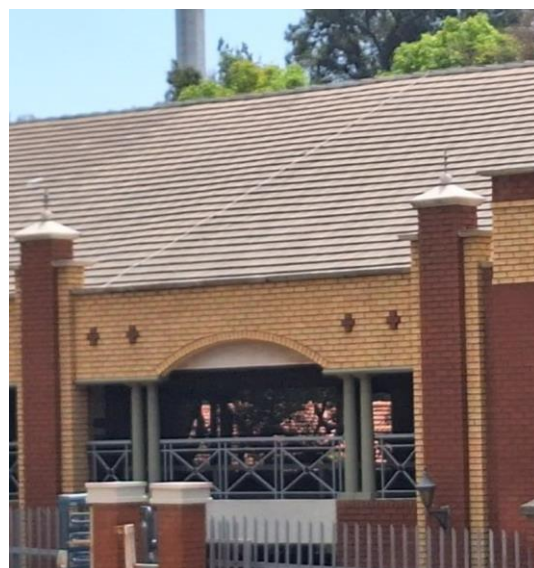
**LPS conductor from roof ridge down to earth spike**

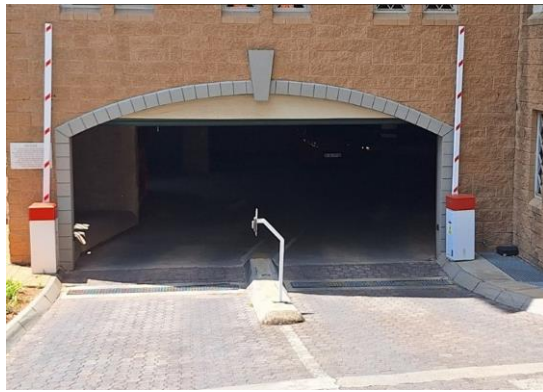
**Access control for booms not operational**

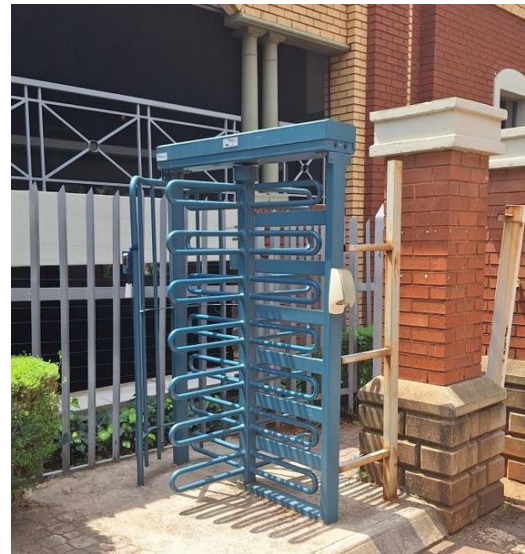
**Turnstile for pedestrians at gate house**

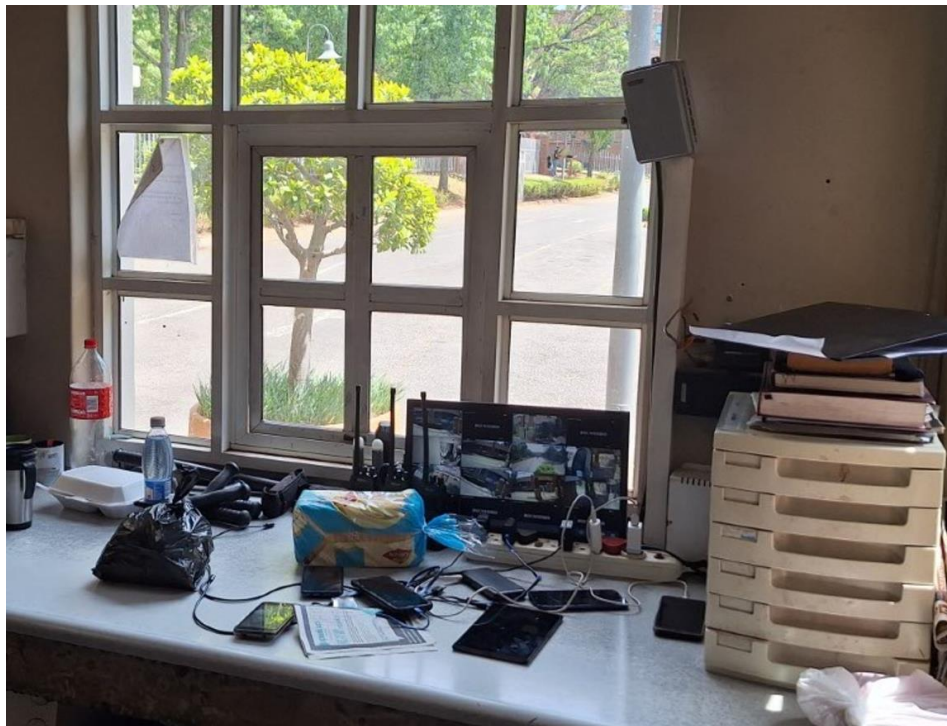
**CCTV monitor at gate house**

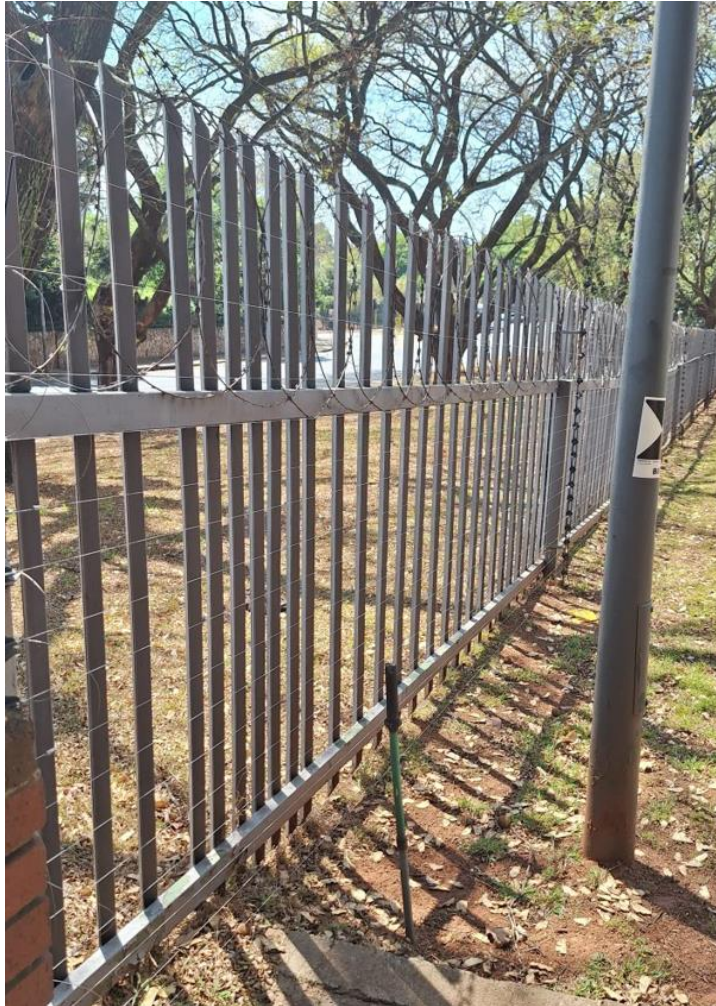
**Electric Fence**

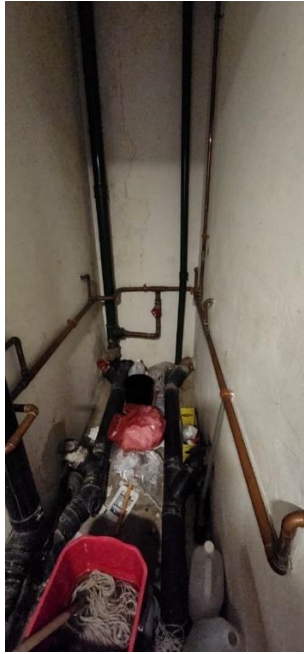
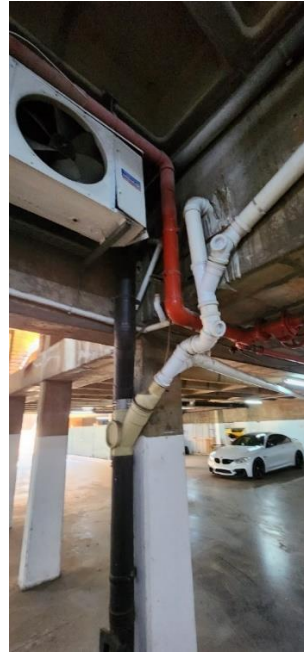
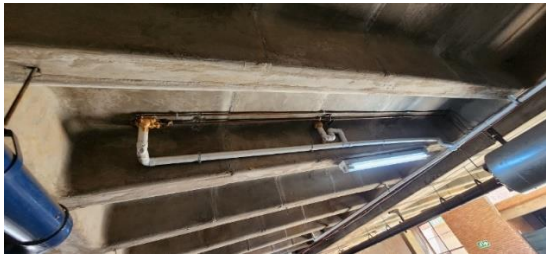
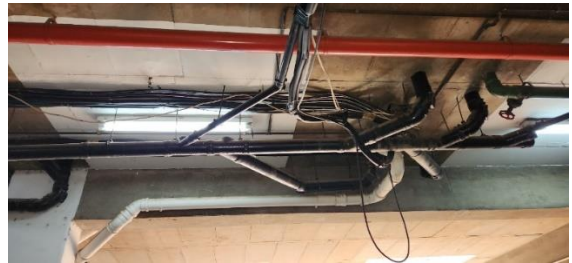
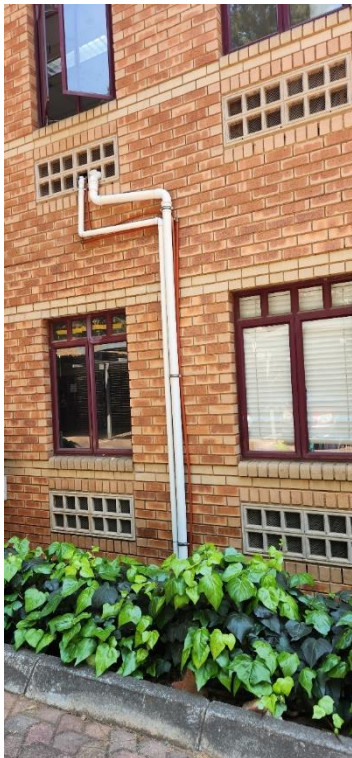
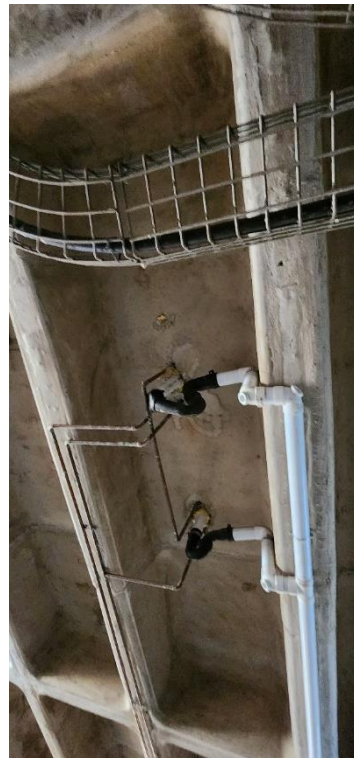
The condition of the piping is in most cases is in fair condition, however the installation requires planned maintenance. Some areas might need more intensive maintenance.

Tenant installations have been installed, which connect to the existing drainage system, some maintenance is required, such as attending to loose fittings, sagging pipes, etc.

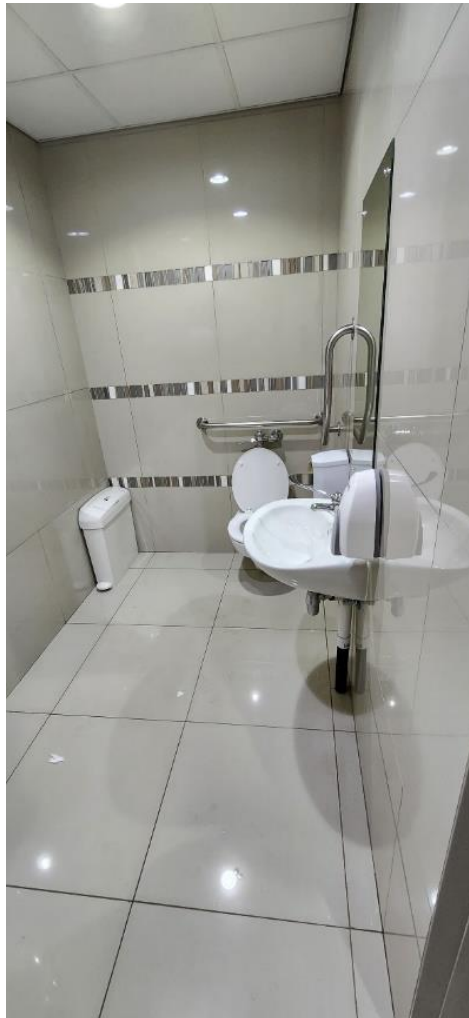
**Typical toilet for Disabled**

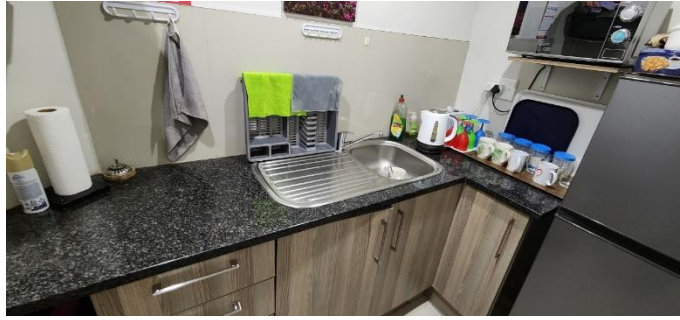
**Typical used tea kitchen**

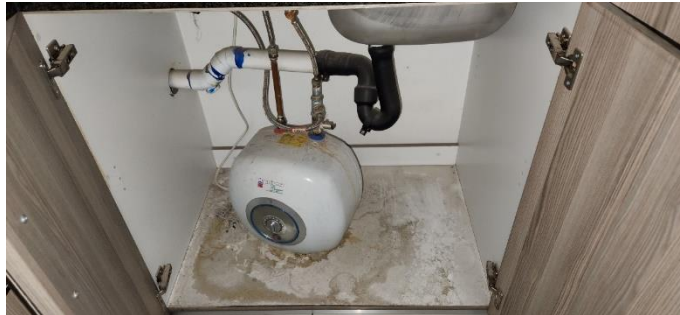
**Tenant installed under counter geyser**

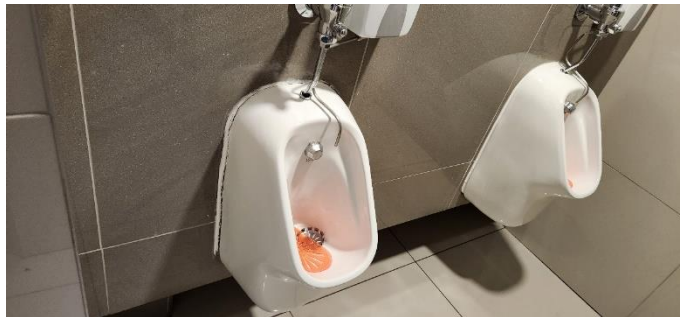
**Refurbished urinals**

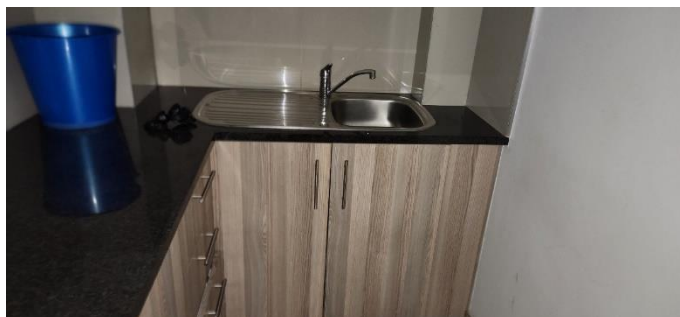
**Typical un-used tea kitchen**

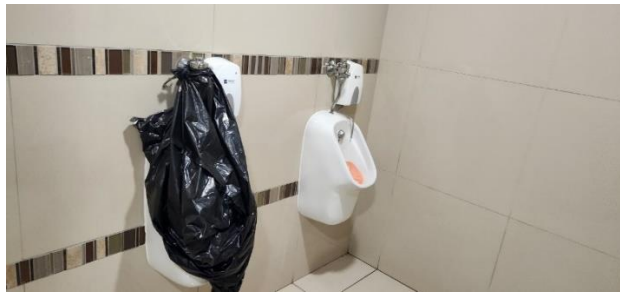
**Refurbished urinals – not working**

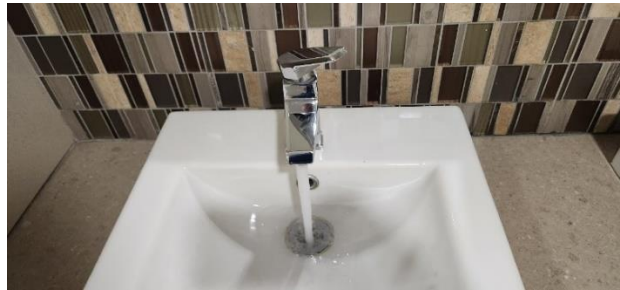
**Typical refurbished wash hand basin**

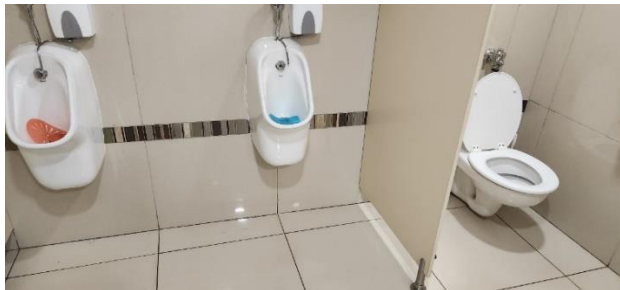
**Typical refurbished toilet core**

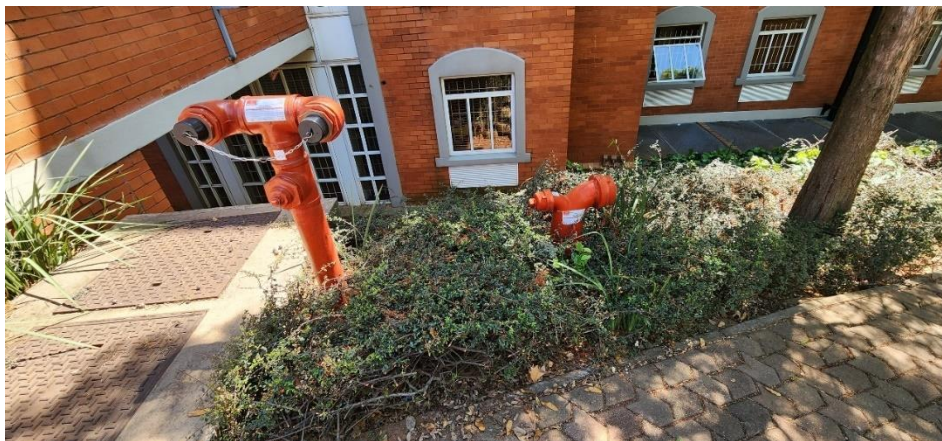
**Typical hydrant booster**

These hydrant boosters require a non-return installed to allow the prevention of boosting back feeding into the ring main, should there be a fire department boost the system during a fire. We would need to see the fire rational design report to further understand the design philosophy of the hydrant and hose reel system.

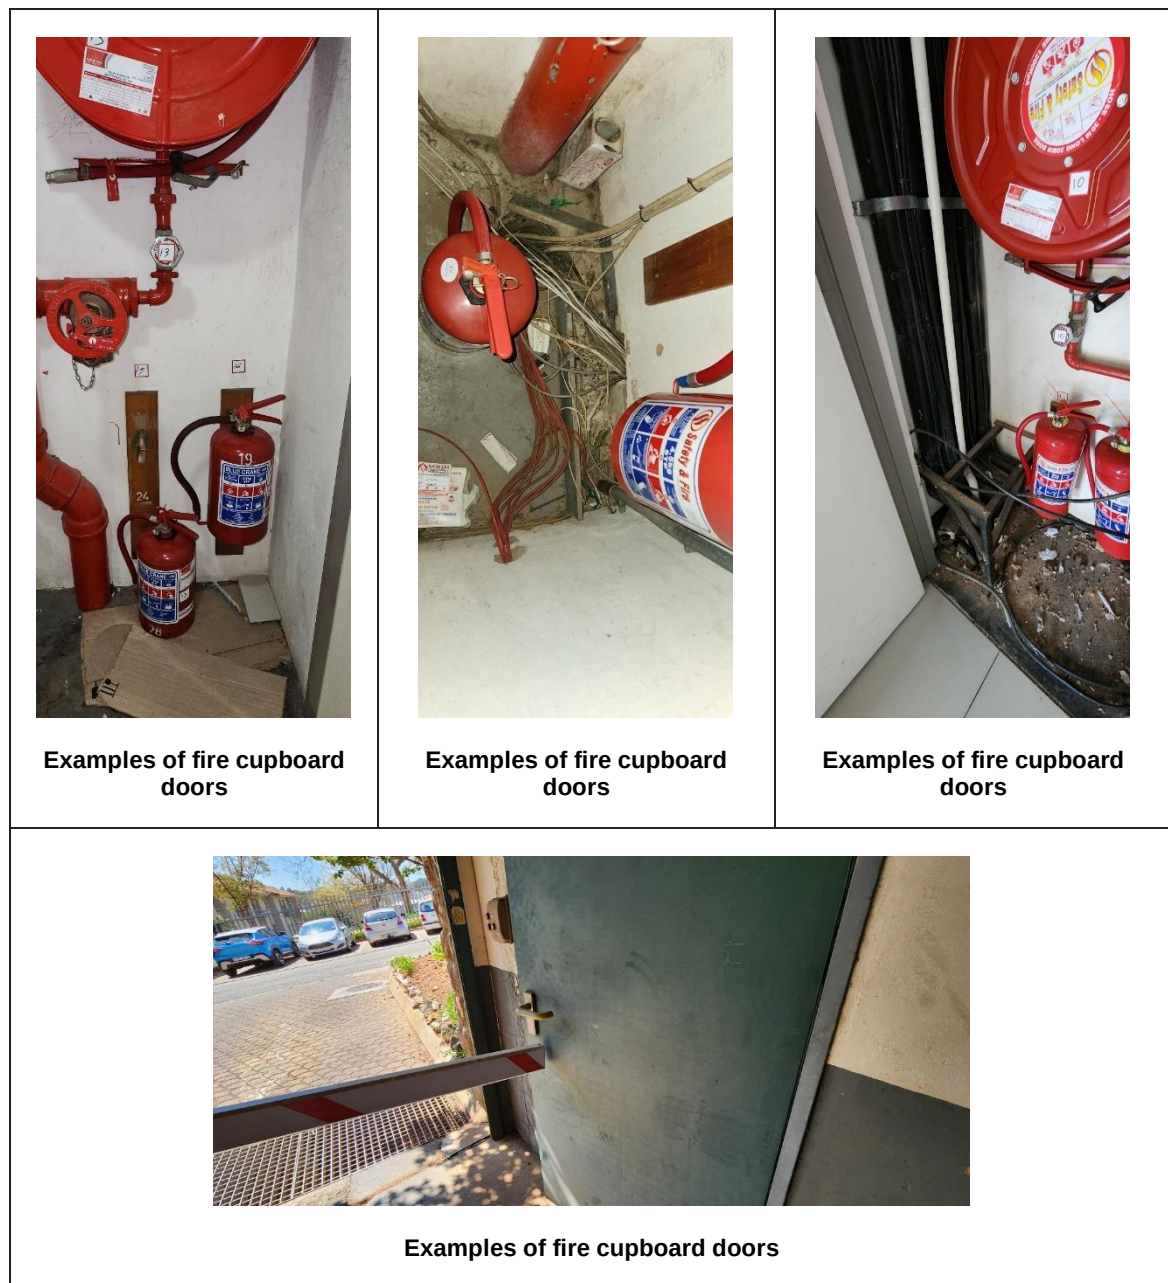
- ▶ All hydrant cupboards need to remain clear of rubbish and other obstructions.
- ▶ Hydrant and fire hose reel cupboards are not to be used as storage spaces.
- ▶ The internal hydrant cupboards all require some attention, such as missing door handles. This is more of a daily maintenance issue.
- ▶ The boom position at the parking entrance to Wild Views needs to be addressed, as the boom is obstructing the opening of the fire hose reel cupboard.

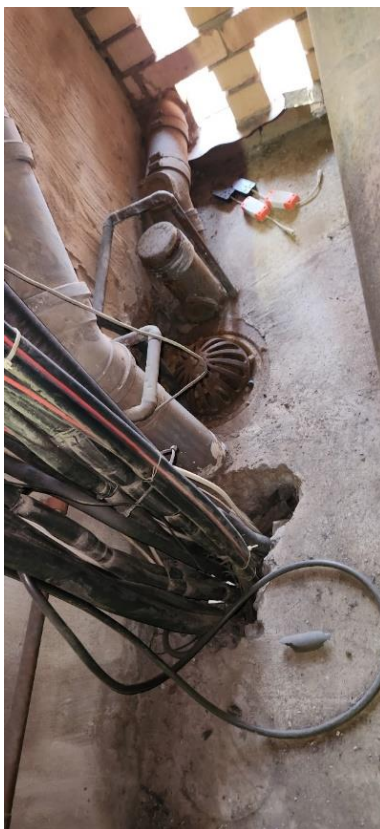
Presently these openings are mainly located inside service ducts for electrical and wet services.

When referencing SANS 10400 Part T Section 4.41, all openings/penetrations through floor slabs shall be sealed and have a fire rating of 120 minutes.

**Fire sealing to be made good throughout various buildings**

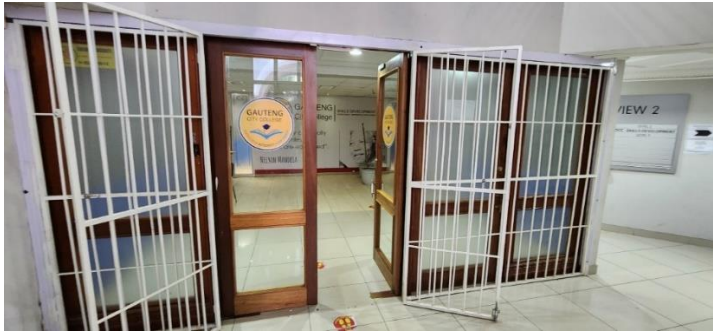
| <p><b>Old Trafford basement</b></p> | |

- ▶ Gauteng City College-
- ▶ Thumb-turn door locks to be provided for the escape-side of emergency exit doors, to allow people to escape.
- ▶ Presently there are existing security gates at major entrance and exit doors. In the case of an emergency and security gates being locked, the escape doors cannot be used as intended. This needs to be rectified.
